Engineering and Geological Effects of the July 2019 Ridgecrest Earthquake Sequence

On behalf of the Geotechnical Extreme Events Reconnaissance (GEER) Association

Abstract

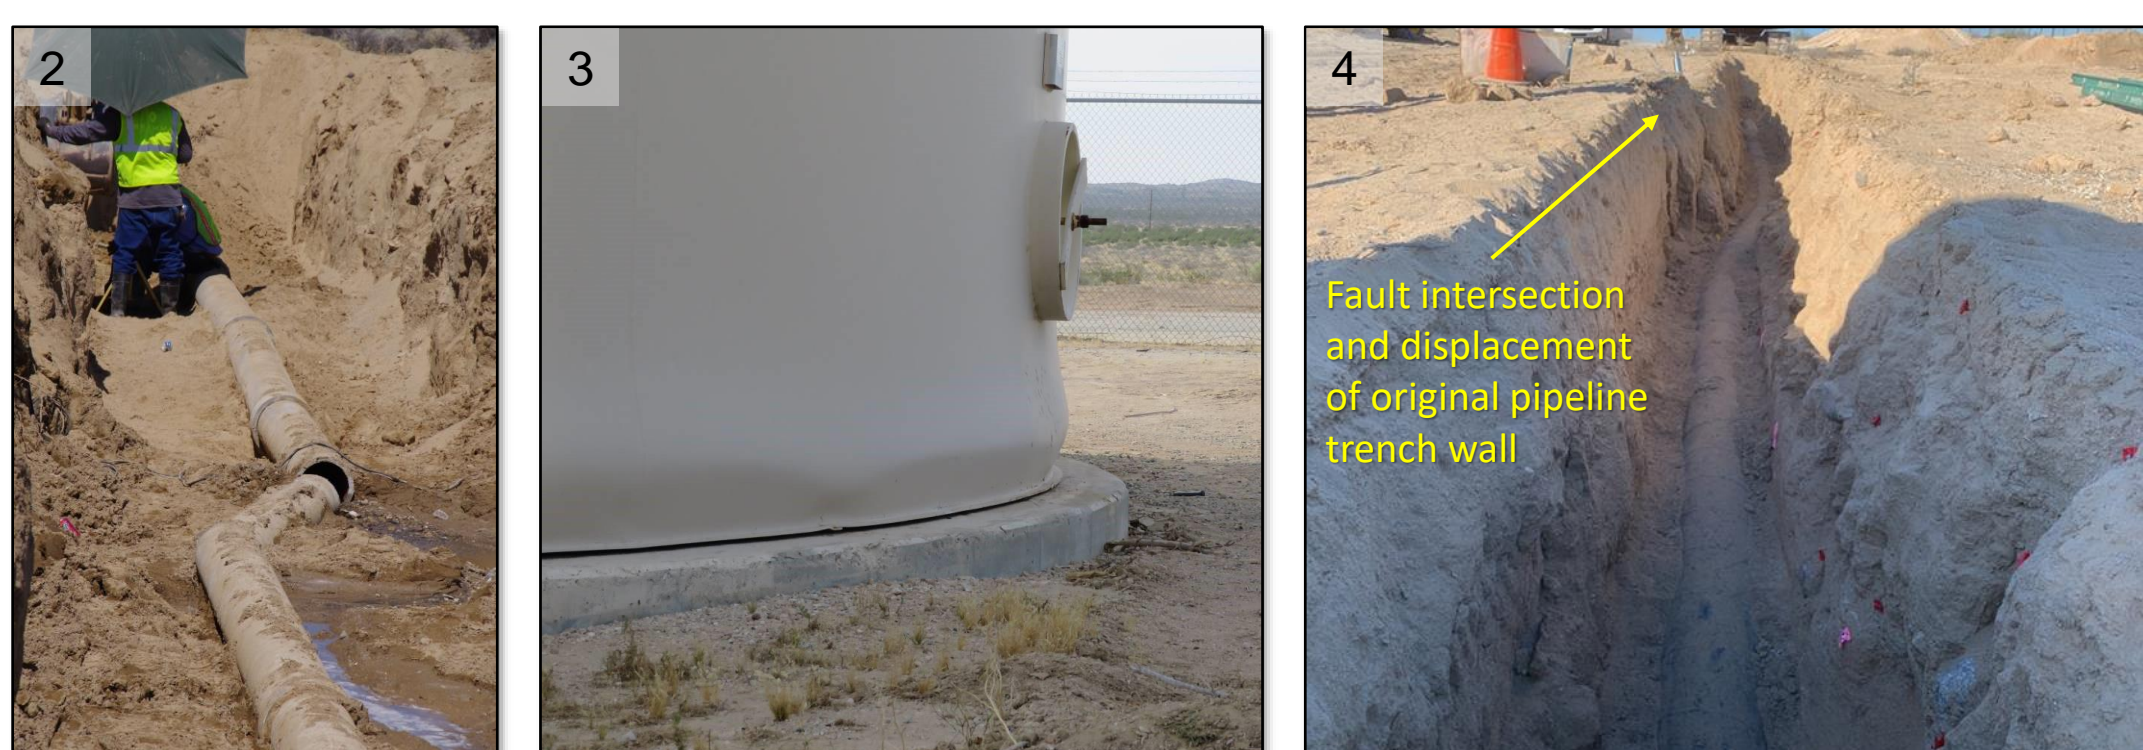
- Highways & Roads:** CA-178 damaged by surface fault rupture up to 1 m; pavement in Trona damaged by lateral spreading; no damage to bridges
- Railroads:** right-lateral displacement of tracks near Trona Pinnacles
- Water Systems:** multiple supply line breaks from fault rupture (Figure 2), and water tank developed elephant's foot bulge (Figure 3).
- Natural Gas:** Surface rupture from both events offset two PG&E gas transmission lines. No ruptures or leaks found; deformed sections were replaced (Figure 4).
- Electric Power:** SoCal Edison outages affected tens of thousands of people.

Figure 2. Offset of buried concrete segmented water pipeline of Searles Domestic Water Company (SDWC) crossing the M7.1 surface fault rupture. **Figure 3.** SDWC Hilltop Tank elephant foot buckle. **Figure 4.** 10.75 inch natural gas transmission line L311 deformed right-laterally by the M7.1 event (PG&E, Bachhuber & Madugo).

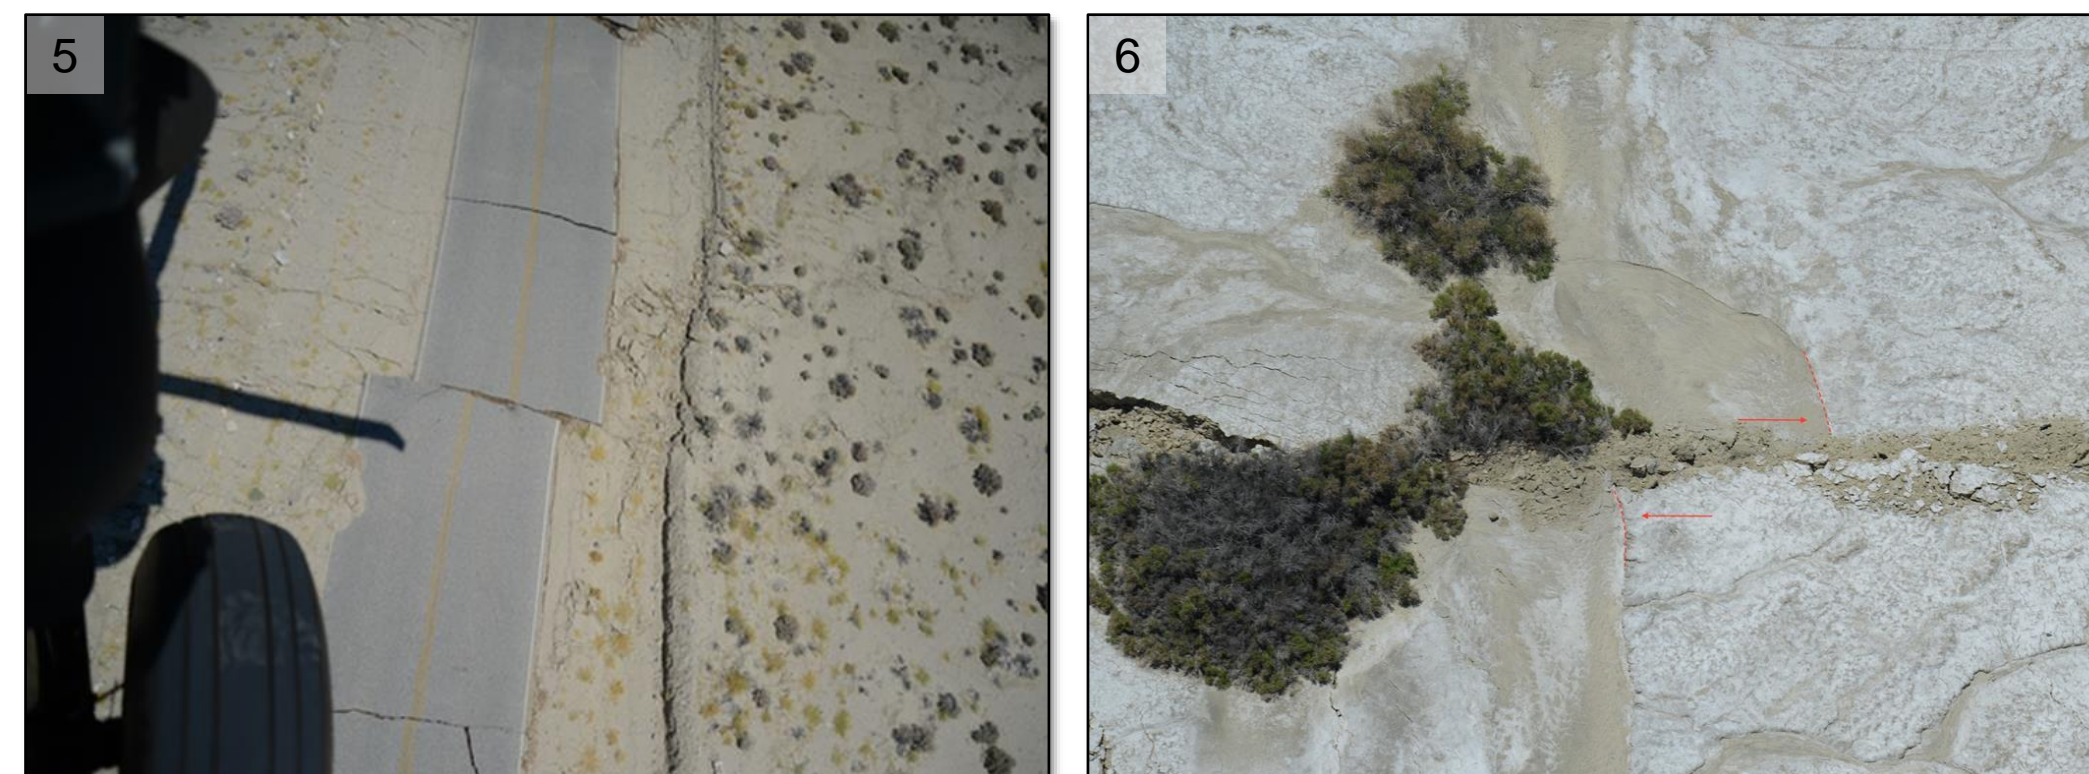
- M7.1 Event:** Surface rupture extent (red lines in Figure 1) mapped within NAWSCL, width varied from few meters in bedrock outcrops to over 300 m in thick soil deposits. Figure 5 shows fault crossing an access road within NAWSCL. Figure 6 shows ~4 m right-lateral offset. Features include left-stepping en-echelon fractures, fissures, and moletrack scarps.

Figure 5. Helicopter overflight viewing access road offset ~2.5 m of right-laterally primary rupture associated with M7.1 event. **Figure 6.** Low-altitude (60 m) helicopter photo showing right-lateral offset of incised channel margin (red dashed line) within dry China Lake bed surface (red arrows indicate sense of slip; approximately 4 m). Correction from Report GEER-064 V2 per Kendrick et al. (Poster #217).

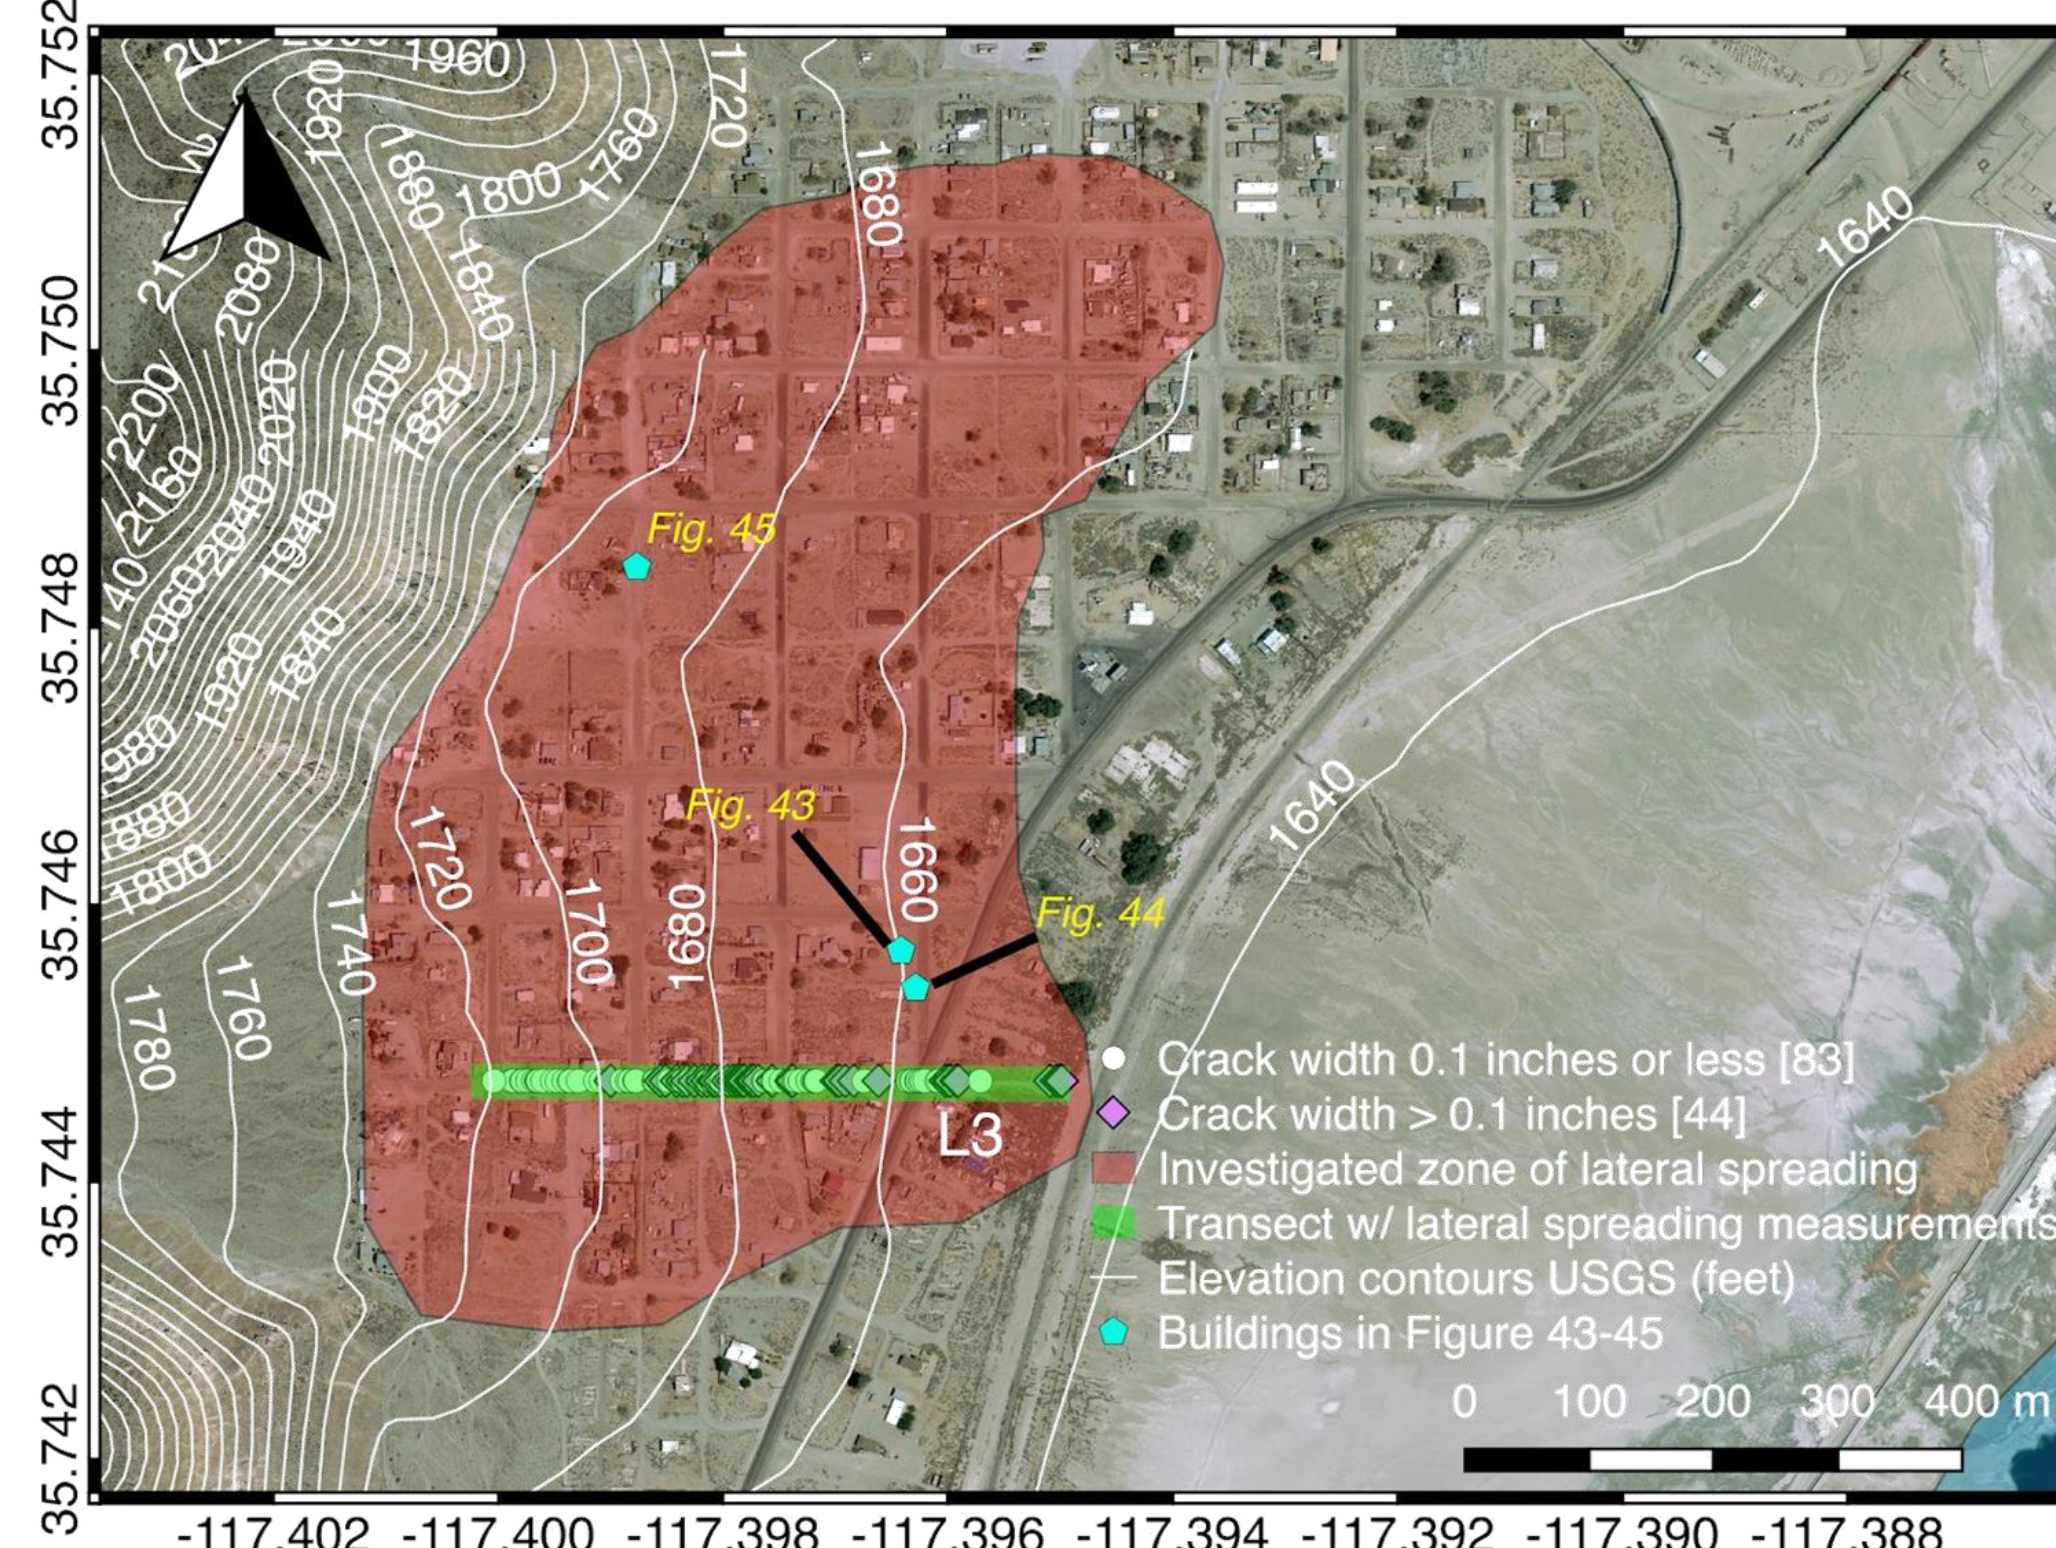
Mapping in regions with and without ground failure in Trona & Argus (Figure 7).

Figure 7. Map of Argus showing region investigated by the GEER team. Lateral spreading features, including tensile cracks and compressional features, were observed throughout the investigated zone. Lateral spread cracks were measured along a transect on A Street, a total of 56 cm over 450 m.

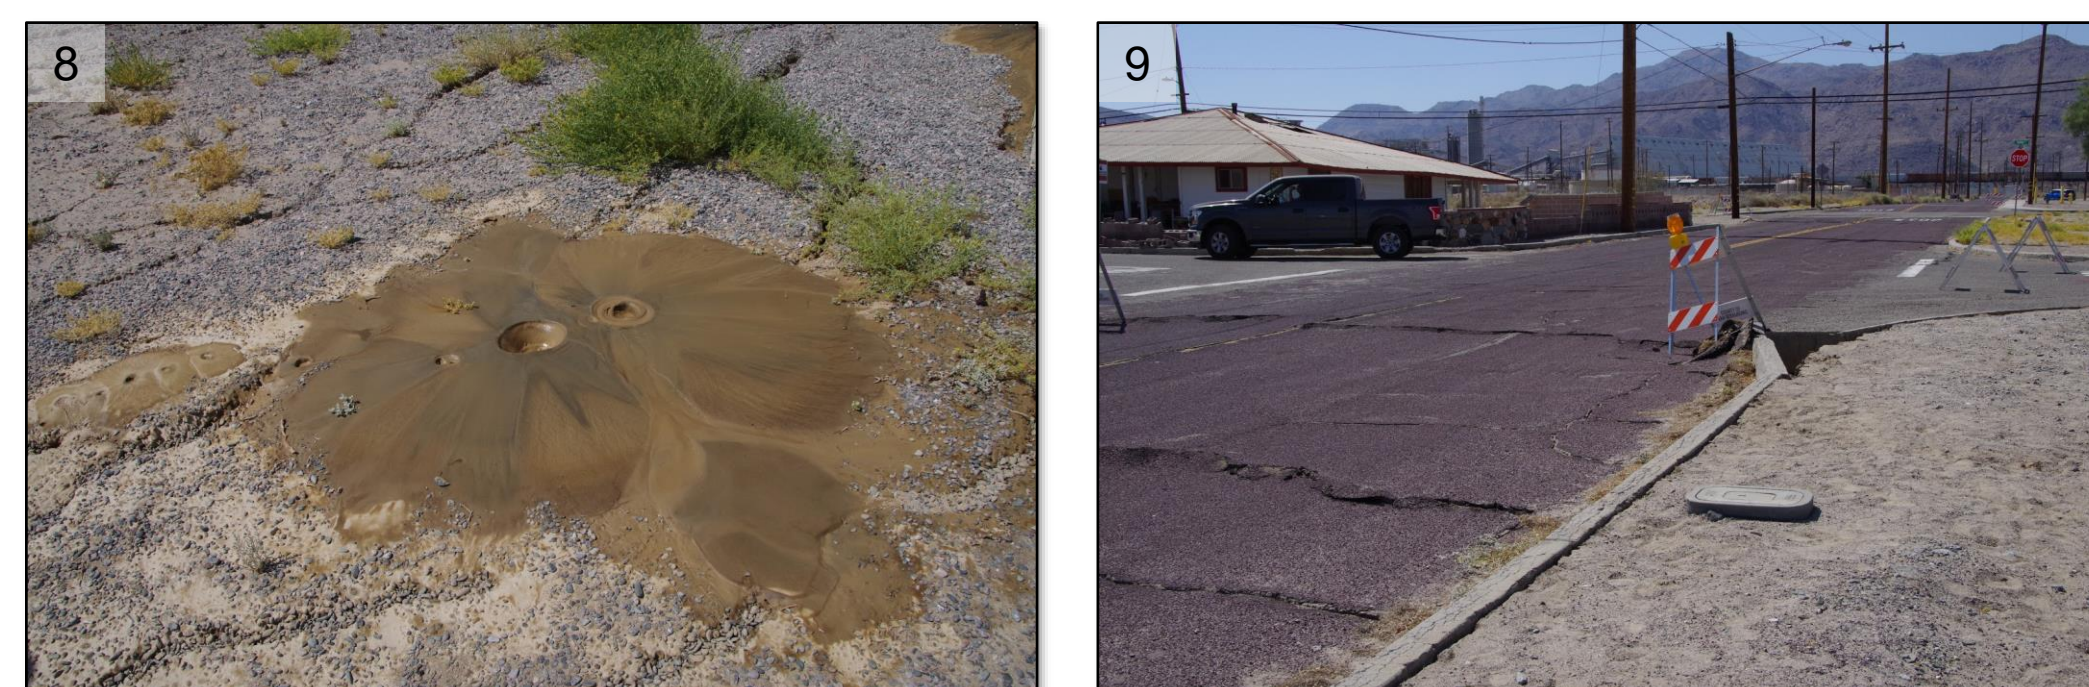
- Liquefaction:** features along margin of Searles Lake in Trona and Argus, including sand boils (Figure 8)
- Lateral spreading:** extension and compression features observed (Figure 9)

Figure 8. Sand boil near margin of Searles Lake in Trona. **Figure 9.** Ground compression, including buckled curb and asphalt pavement, due to liquefaction-induced lateral spreading in Trona.

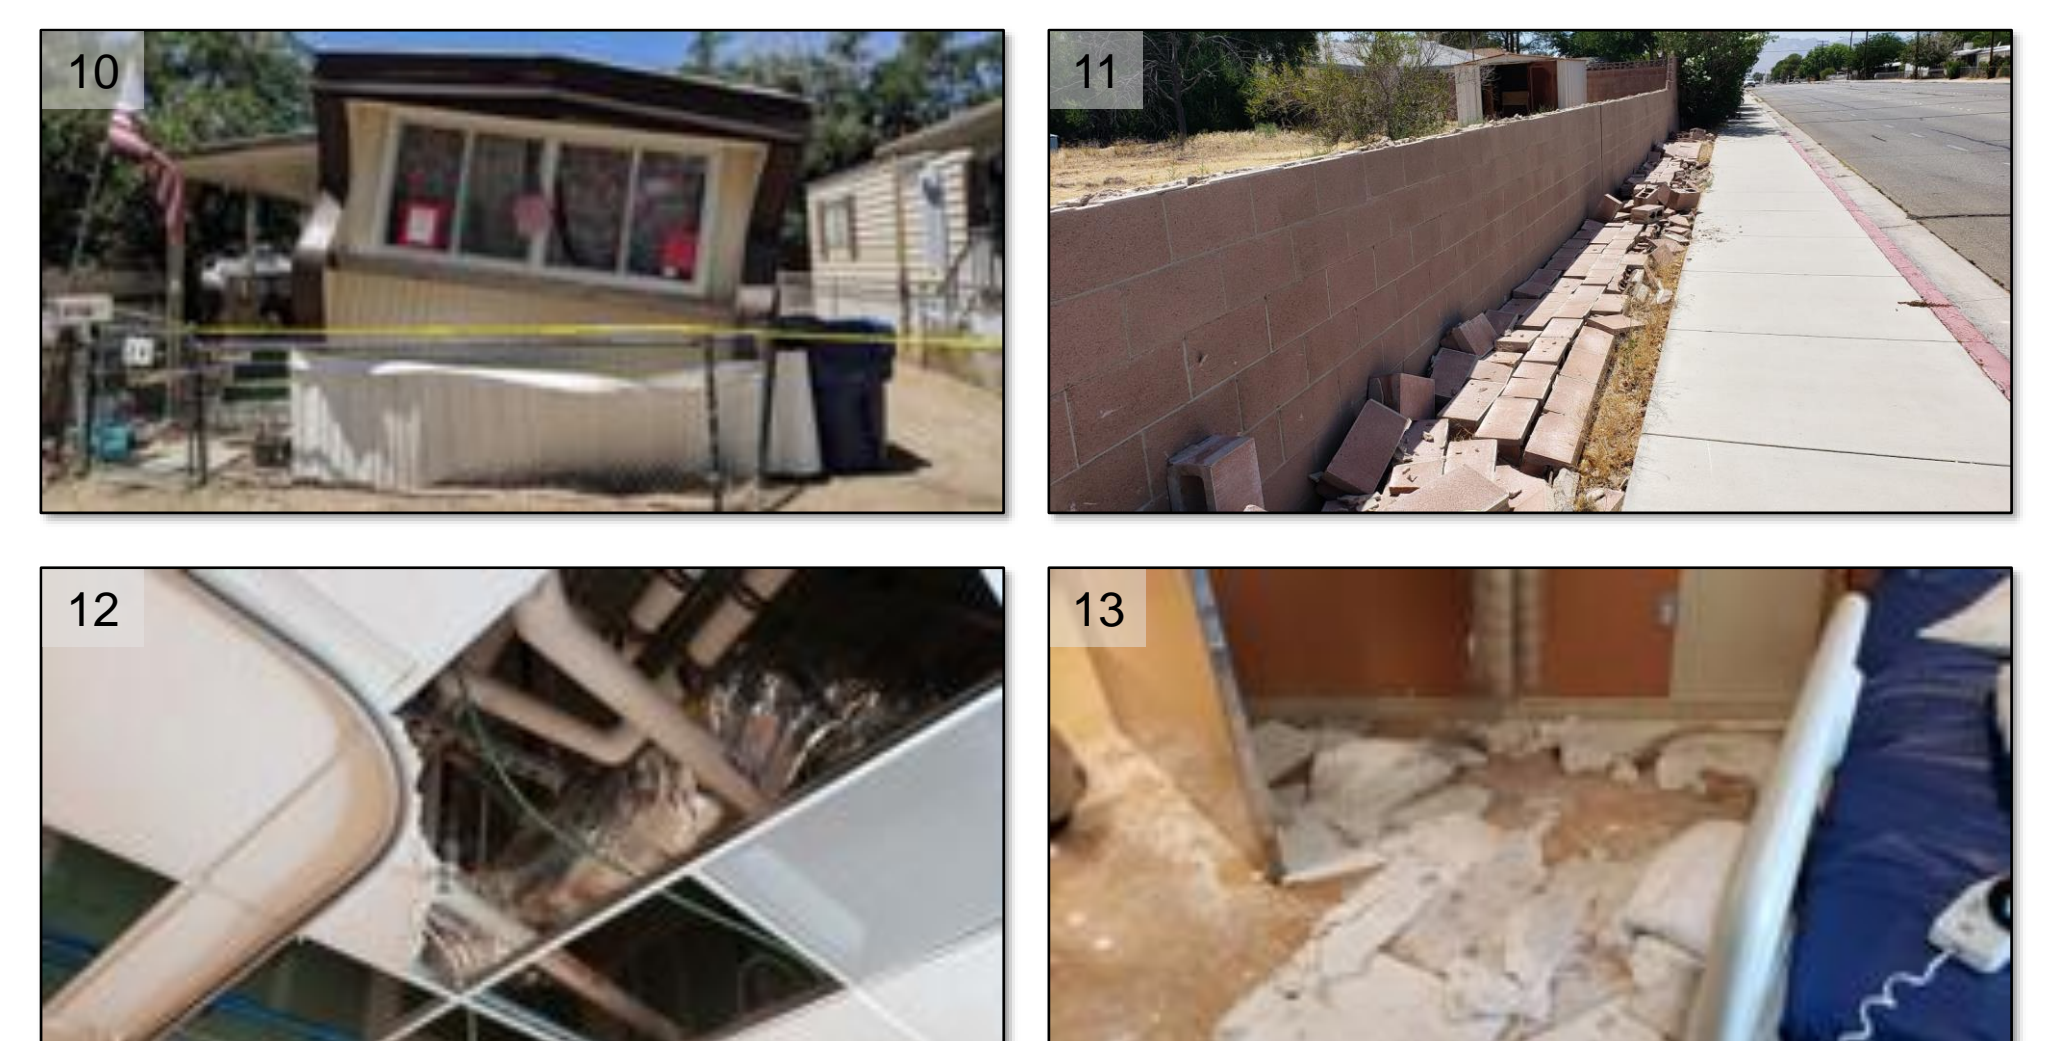
- Wood-frame Structures:** generally good performance despite strong shaking near design ground motion levels in ASCE 7
- Mobile Homes:** significant damage after both events – falling from supports
- Ridgecrest Regional Hospital:** no observable structural damage, mostly nonstructural (pipes, sprinklers, partition walls); shut down after M6.4 event
- Masonry:** walls and chimneys collapsed, cracked horizontally/vertically
- Higher rates of damage in older buildings in liquefied vs non-liquefied ground

Figure 10. Mobile home tilting due to falling from foundation support. **Figure 11.** Residential masonry wall partial collapse after M7.1 event. **Figures 12 and 13.** Nonstructural damage to Ridgecrest Regional Hospital.

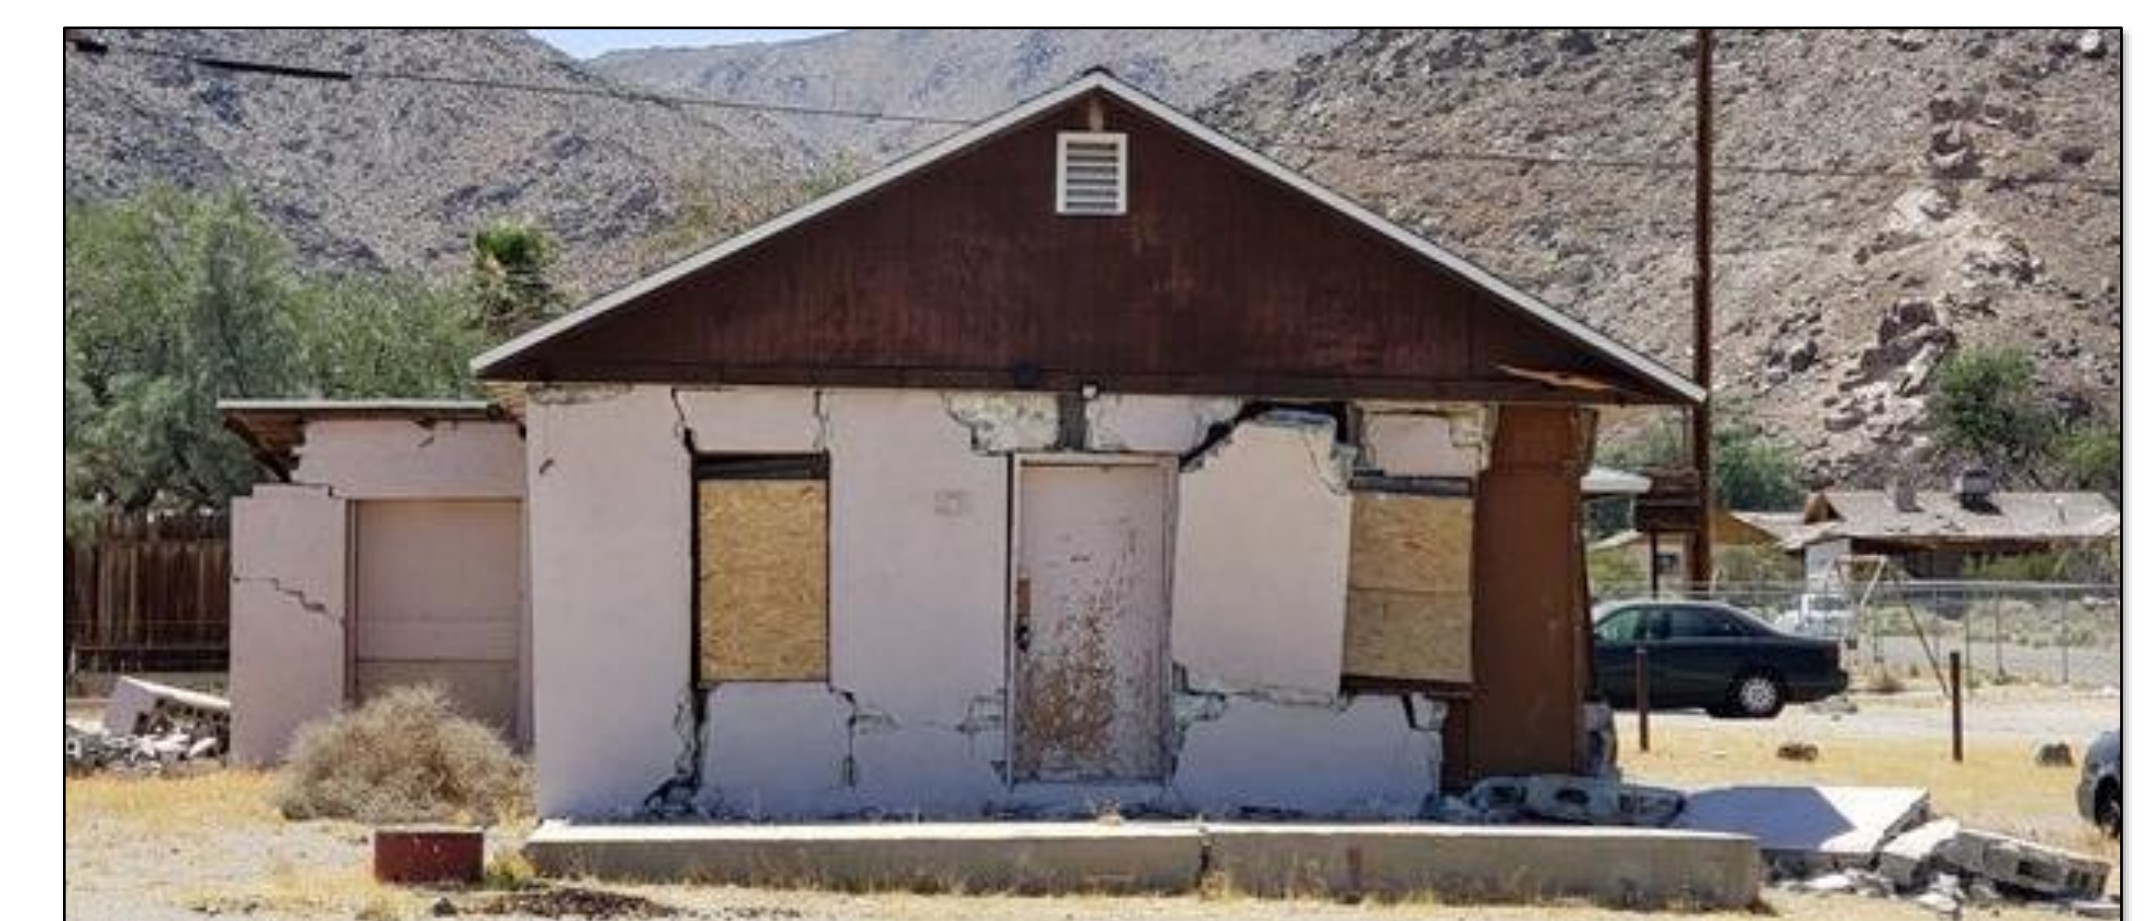
Figure 14. Example of more heavily damaged structure in vicinity of liquefaction-induced ground cracking (upon alluvial fan deposits – see canyon visible behind structure).

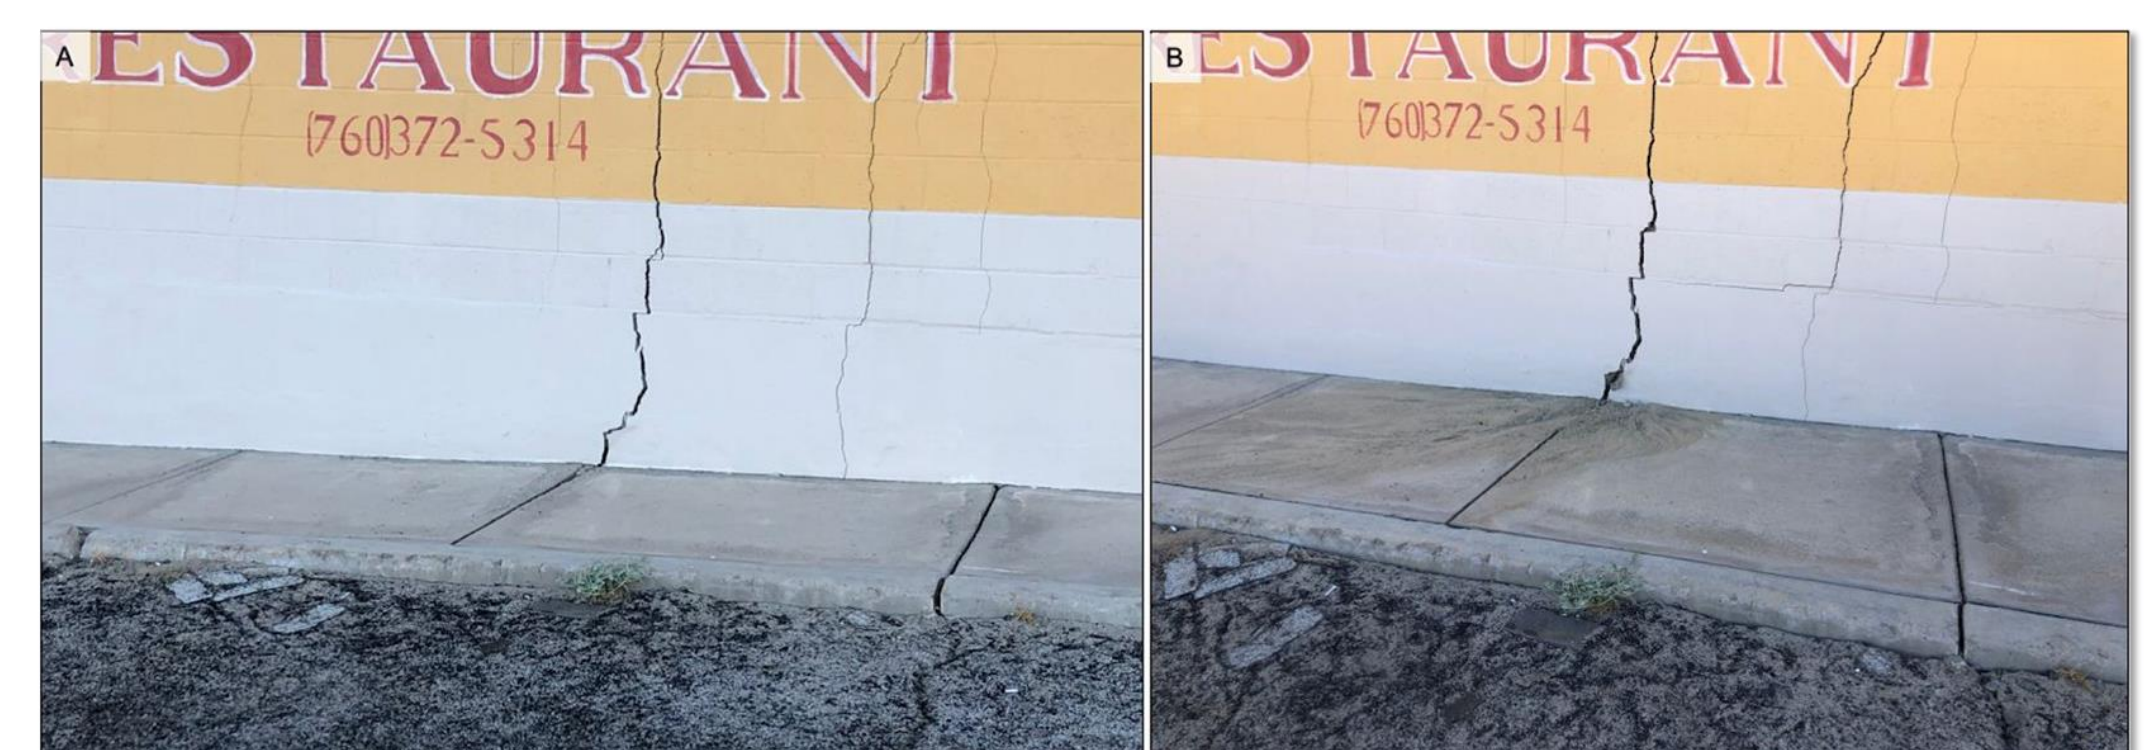
Figure 15. Esparza Restaurant building in Trona that exhibited cracked walls, (A) After the M6.4 earthquake and before the M7.1, and (B) after the M7.1 earthquake. Following the M7.1 earthquake, the horizontal and vertical cracks widened, the roof showed damage and a sand boil appeared at the base of the crack shown in the photo.
