Kumamoto earthquake: a complex earthquake sequence with large strike-slip ruptures

Koji Okumura (Hiroshima University)
kojiok@hiroshima-u.ac.jp

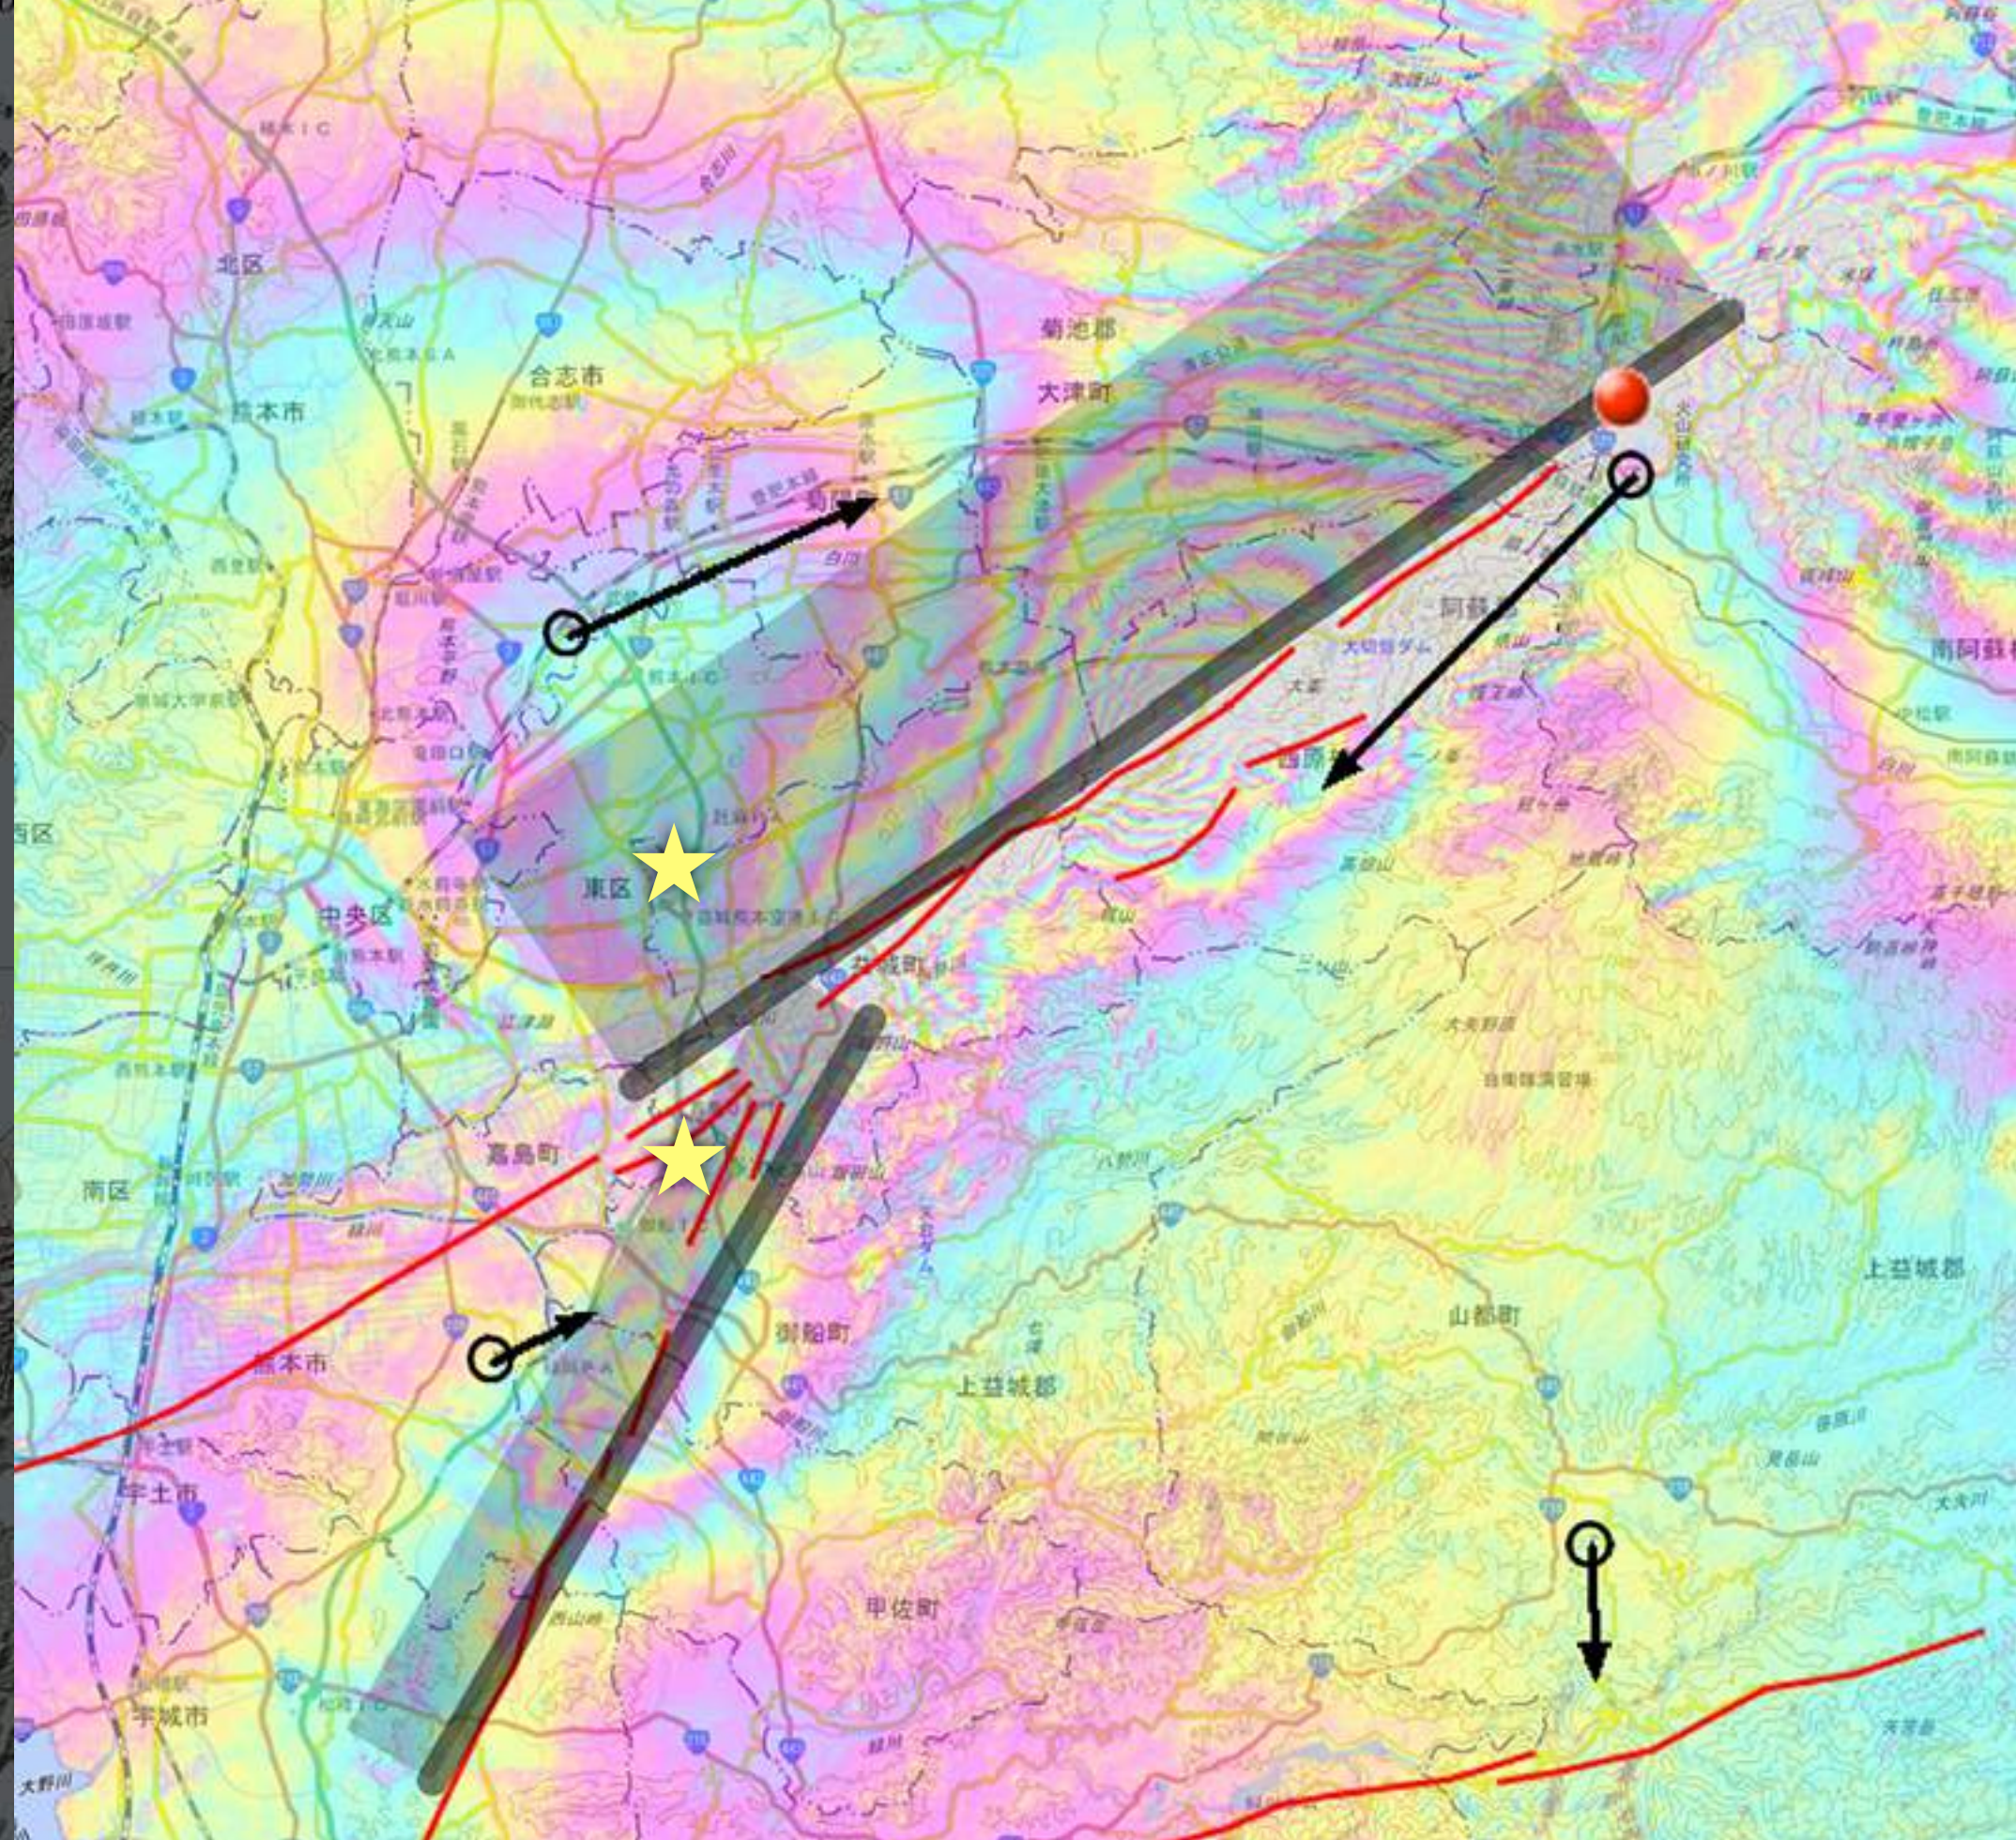
GSI Geonet GNSS source fault model and ALOS-2 InSAR

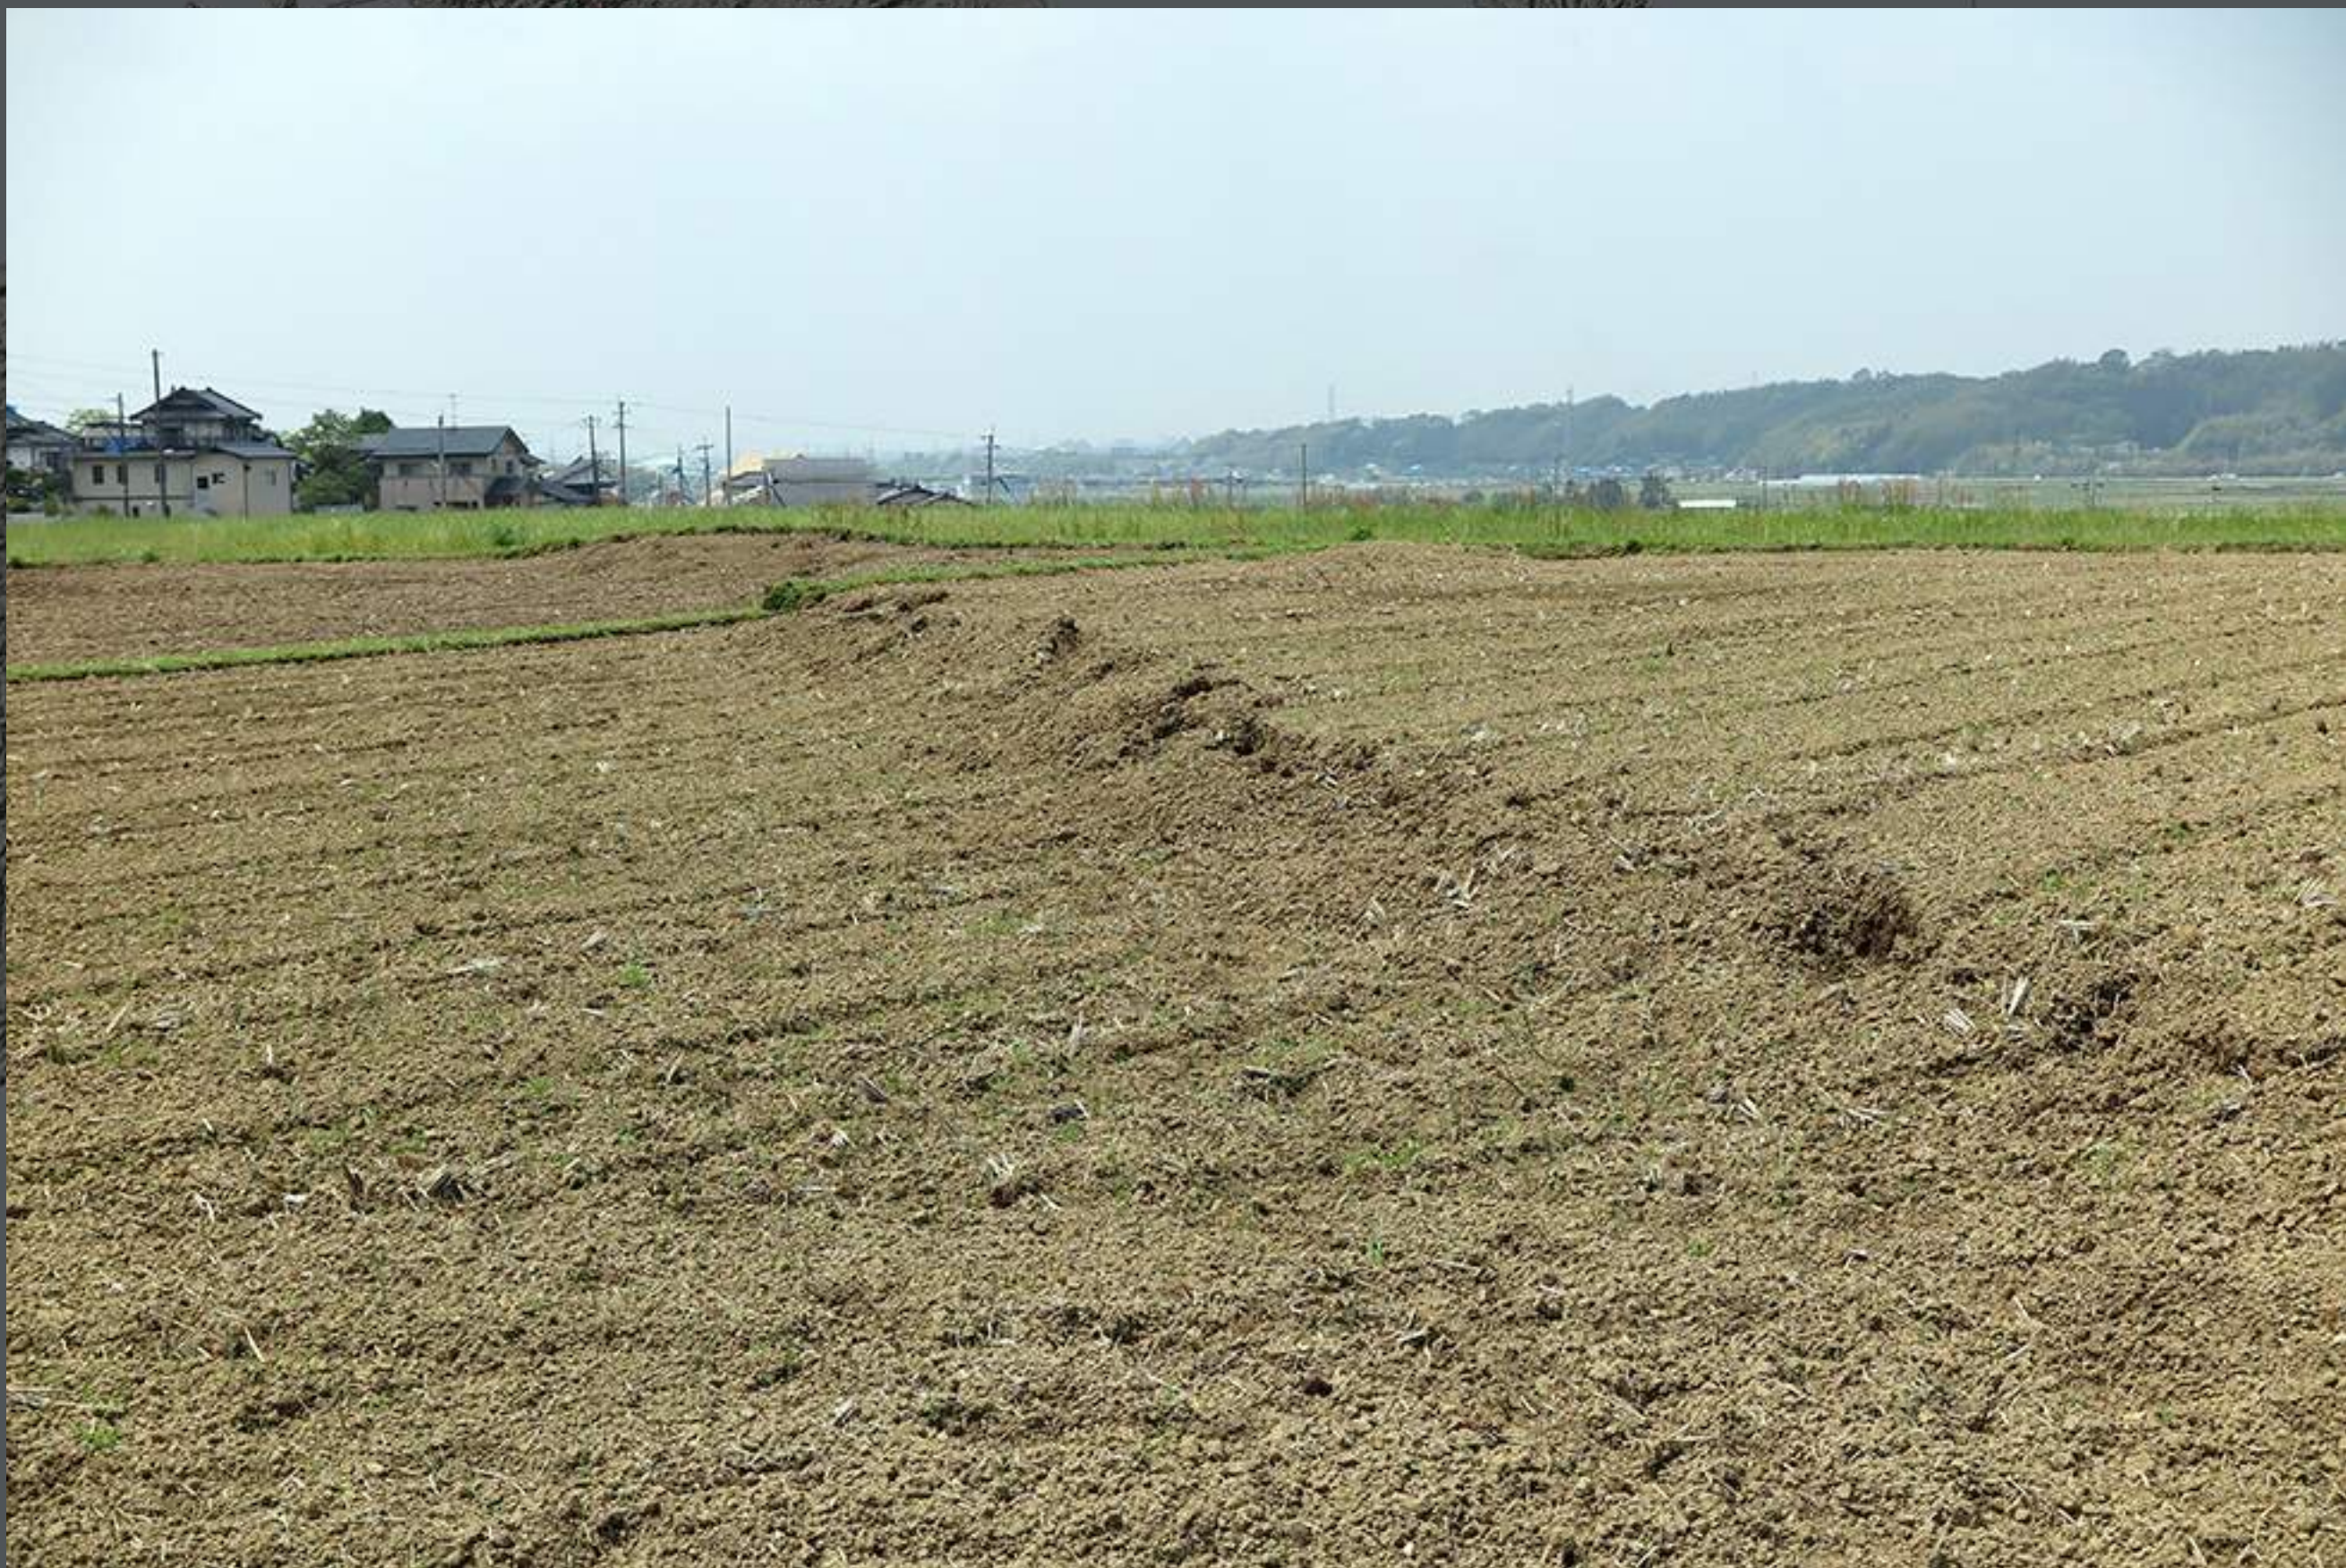
South-side-down master fault at loc. A.

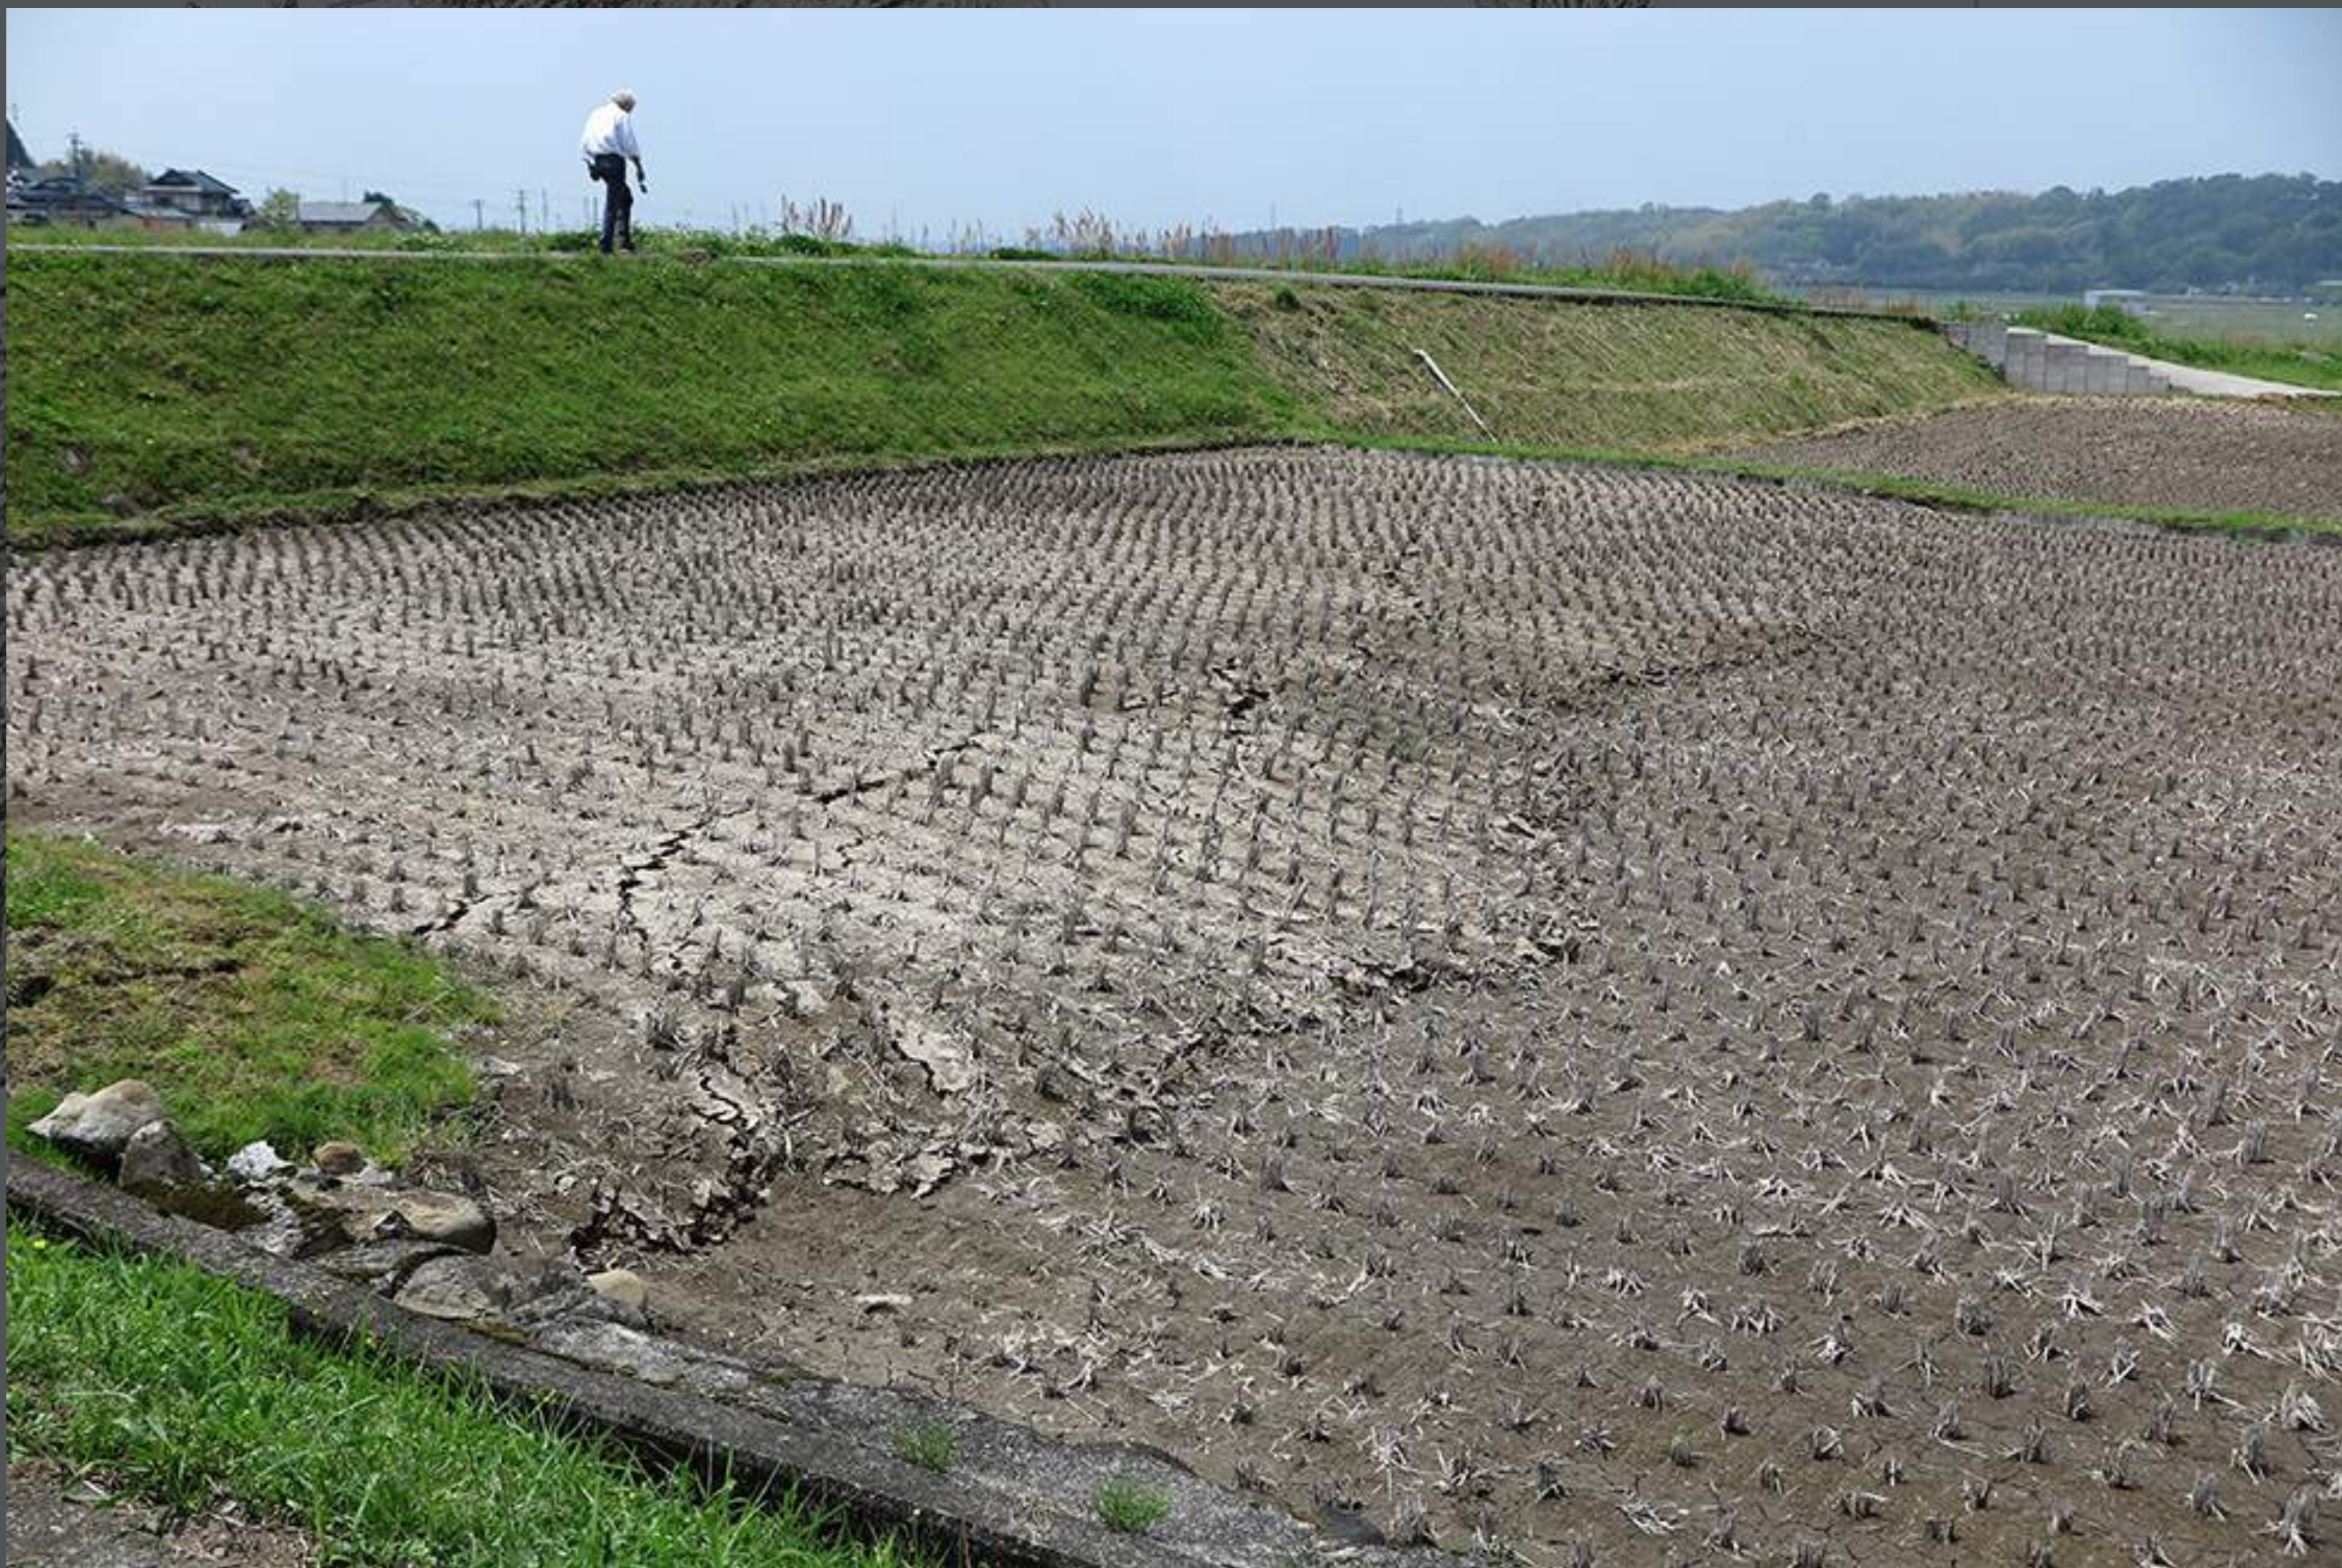
Deformed (or flexures) paddy at loc. B

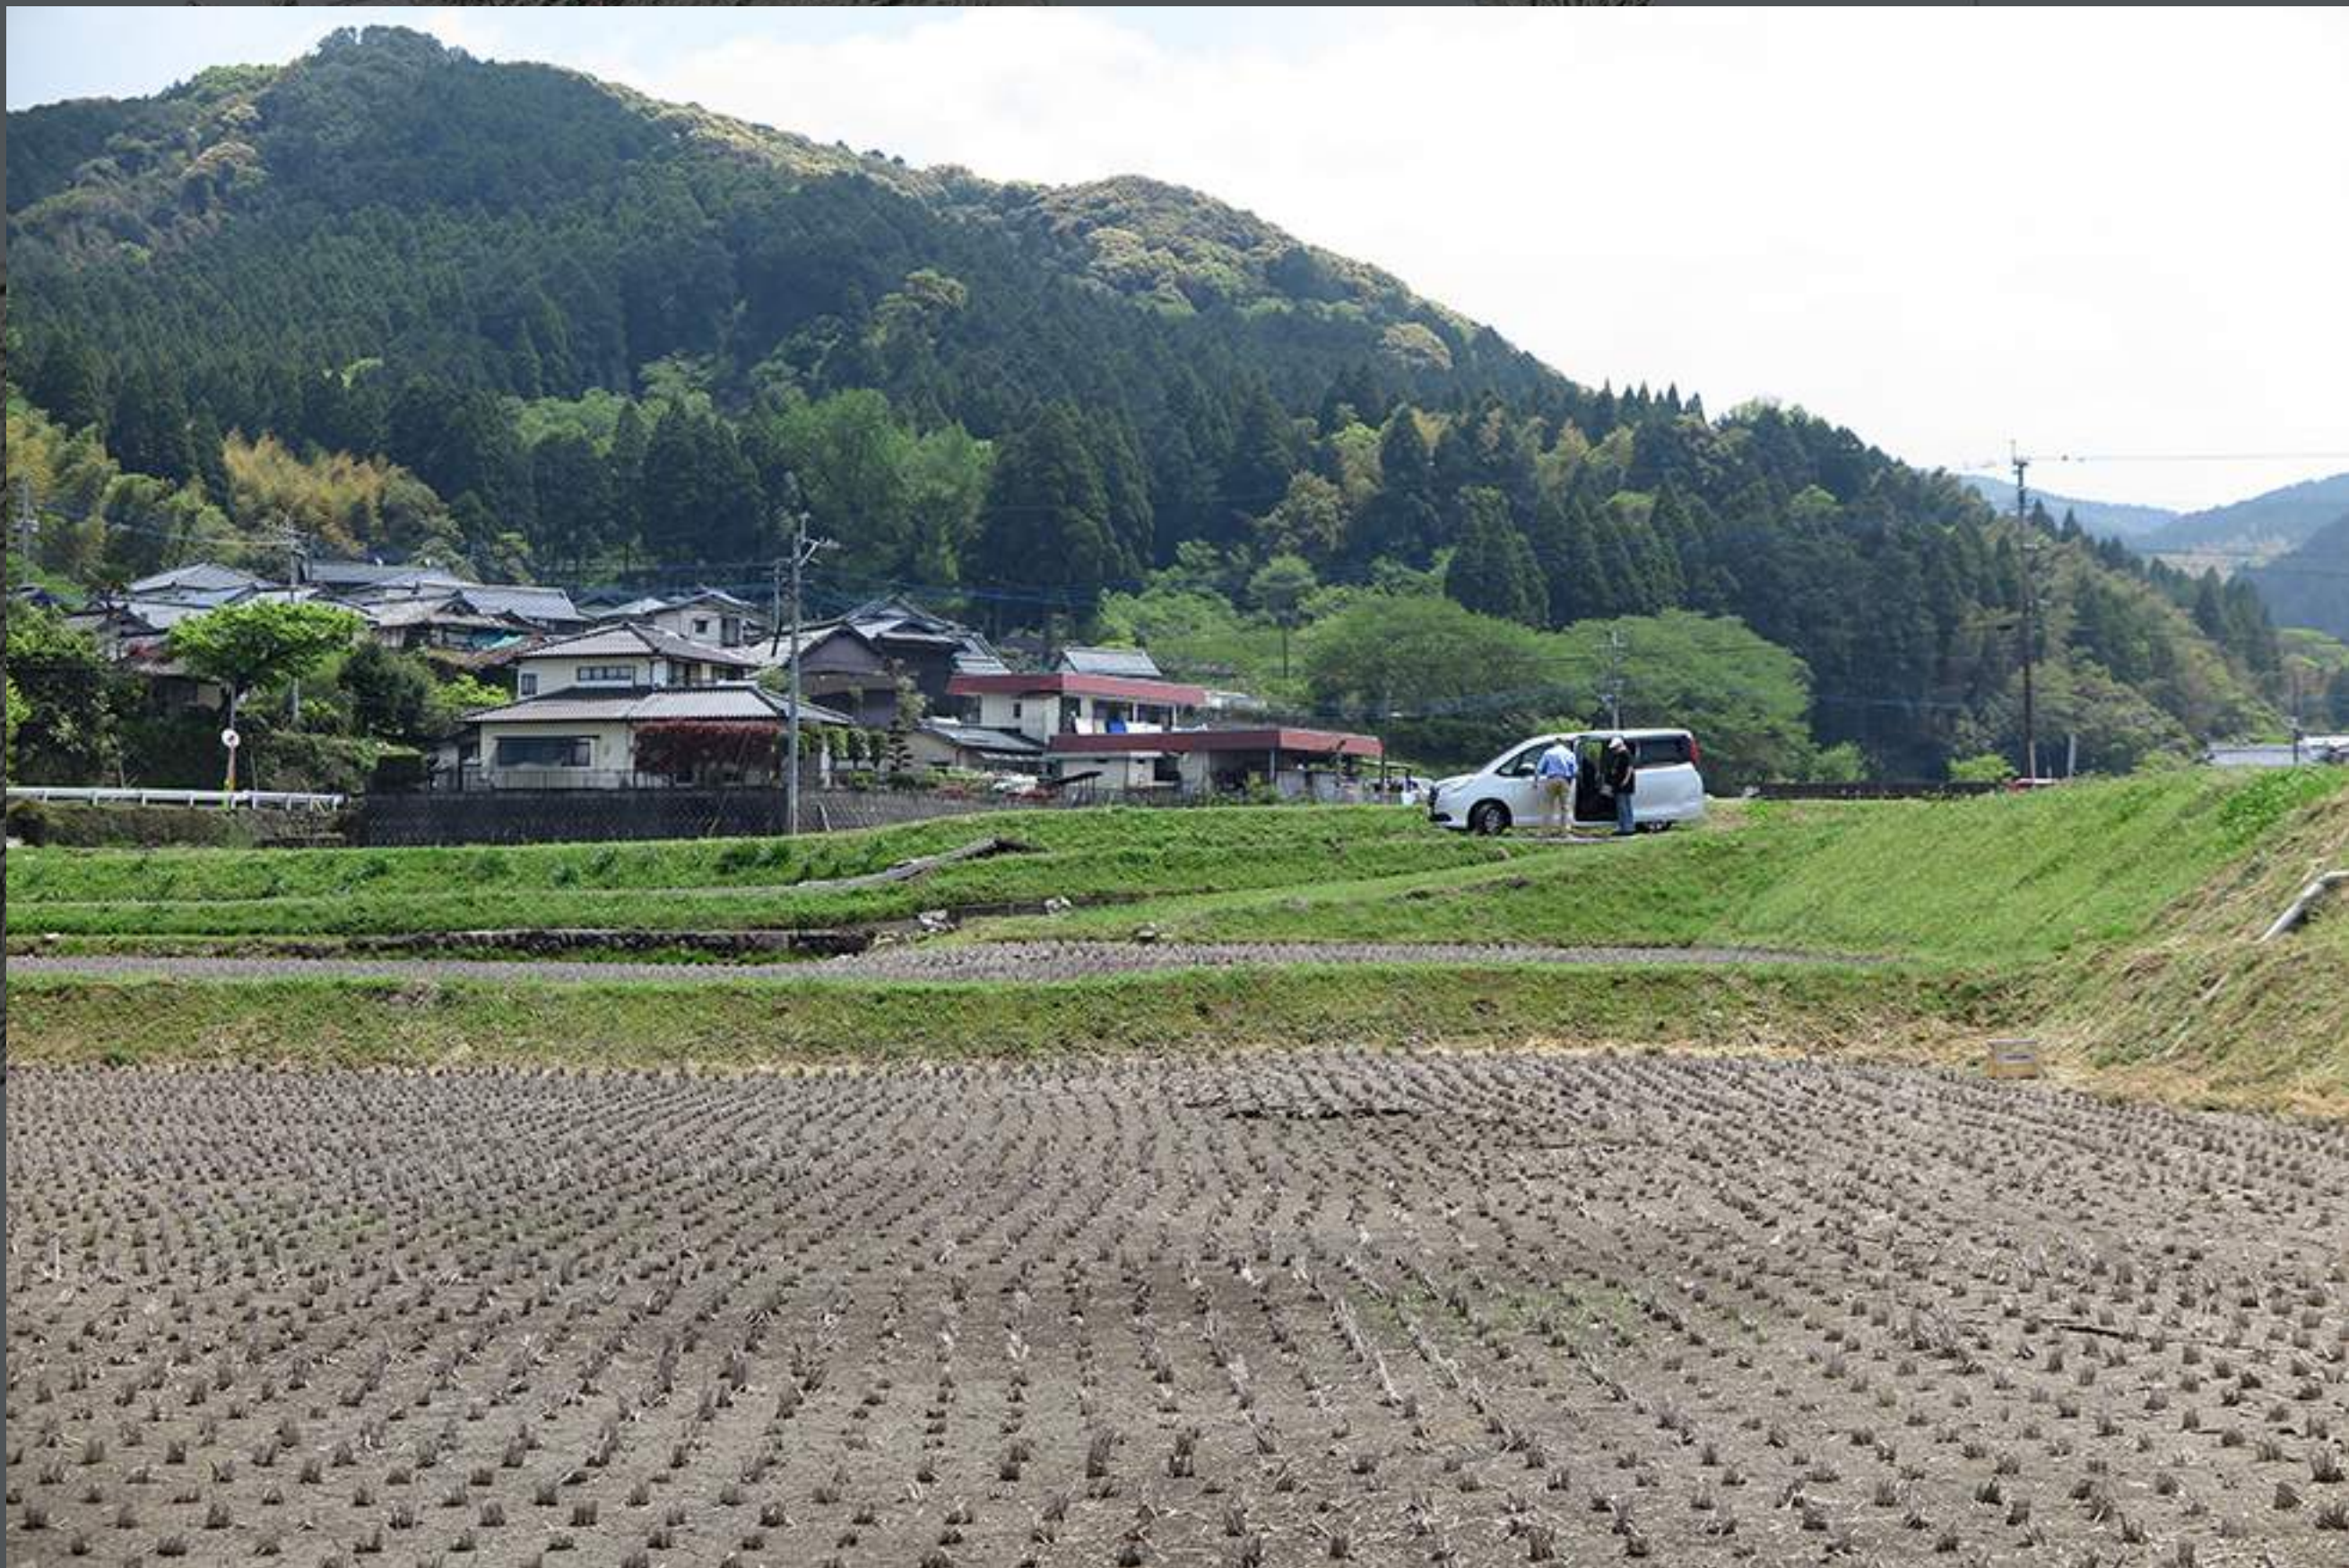
Deformed (or flexures) paddy at loc. B

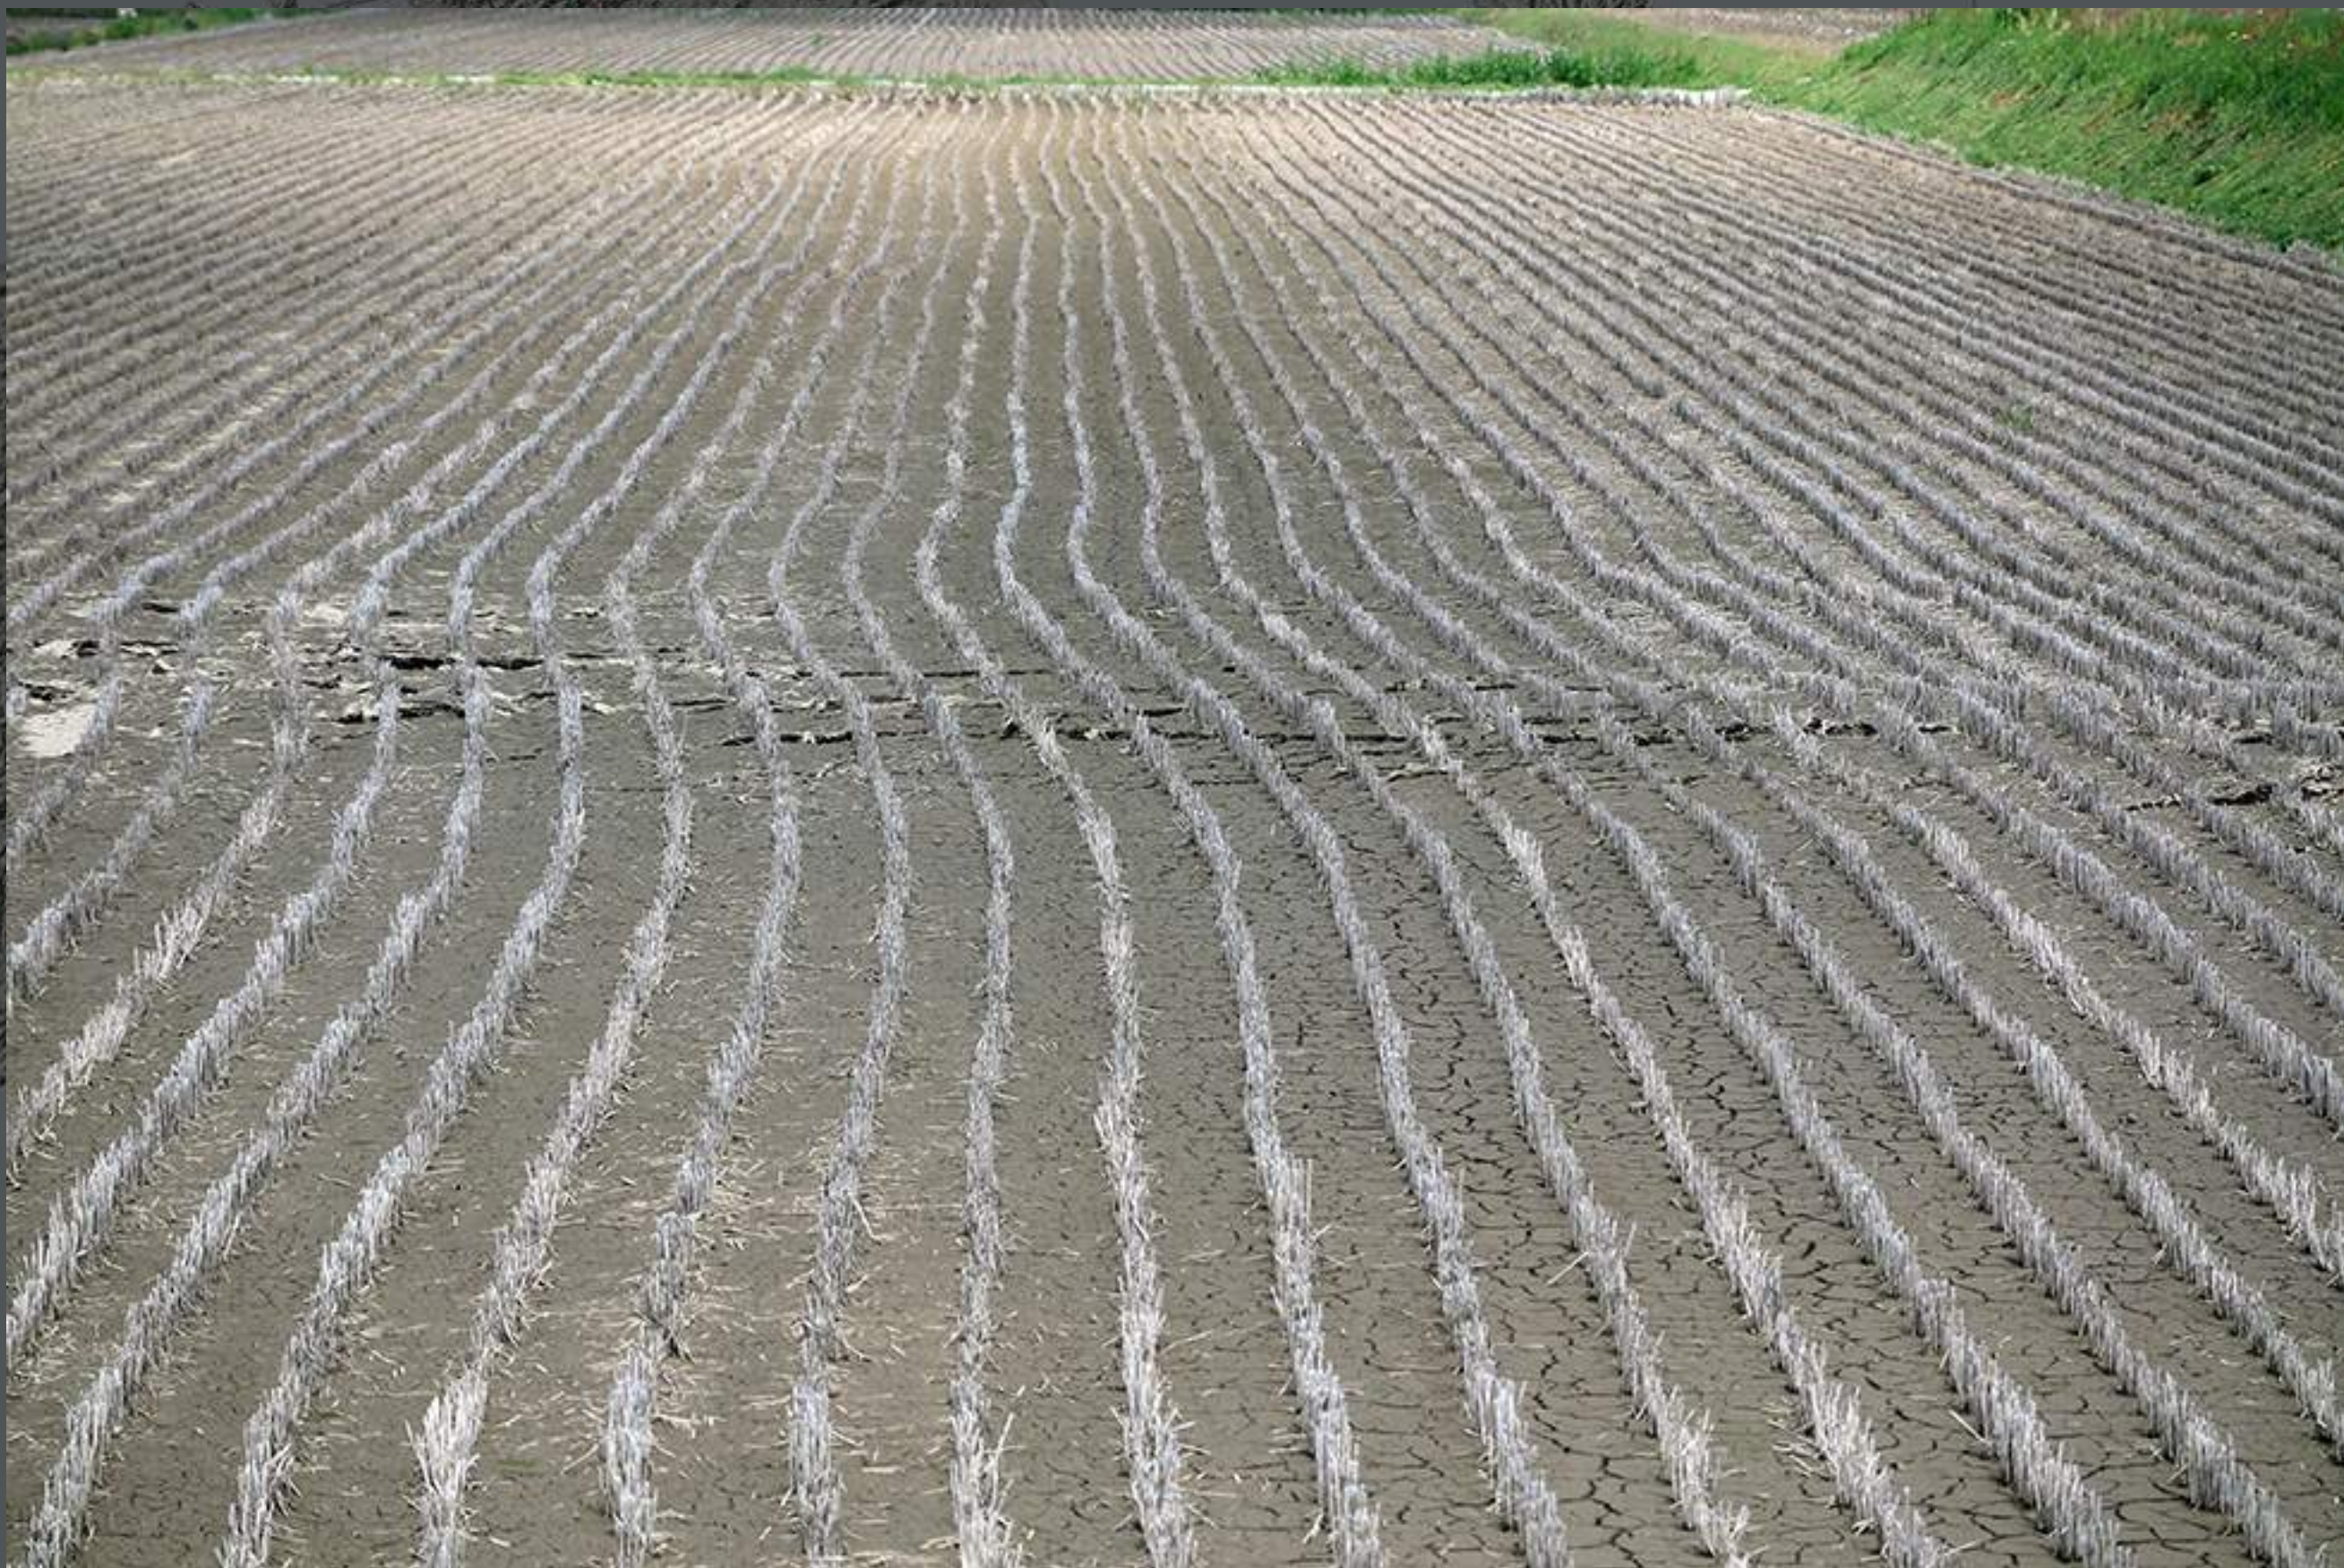
Left-lateral strike slip of rice stubble at loc. B

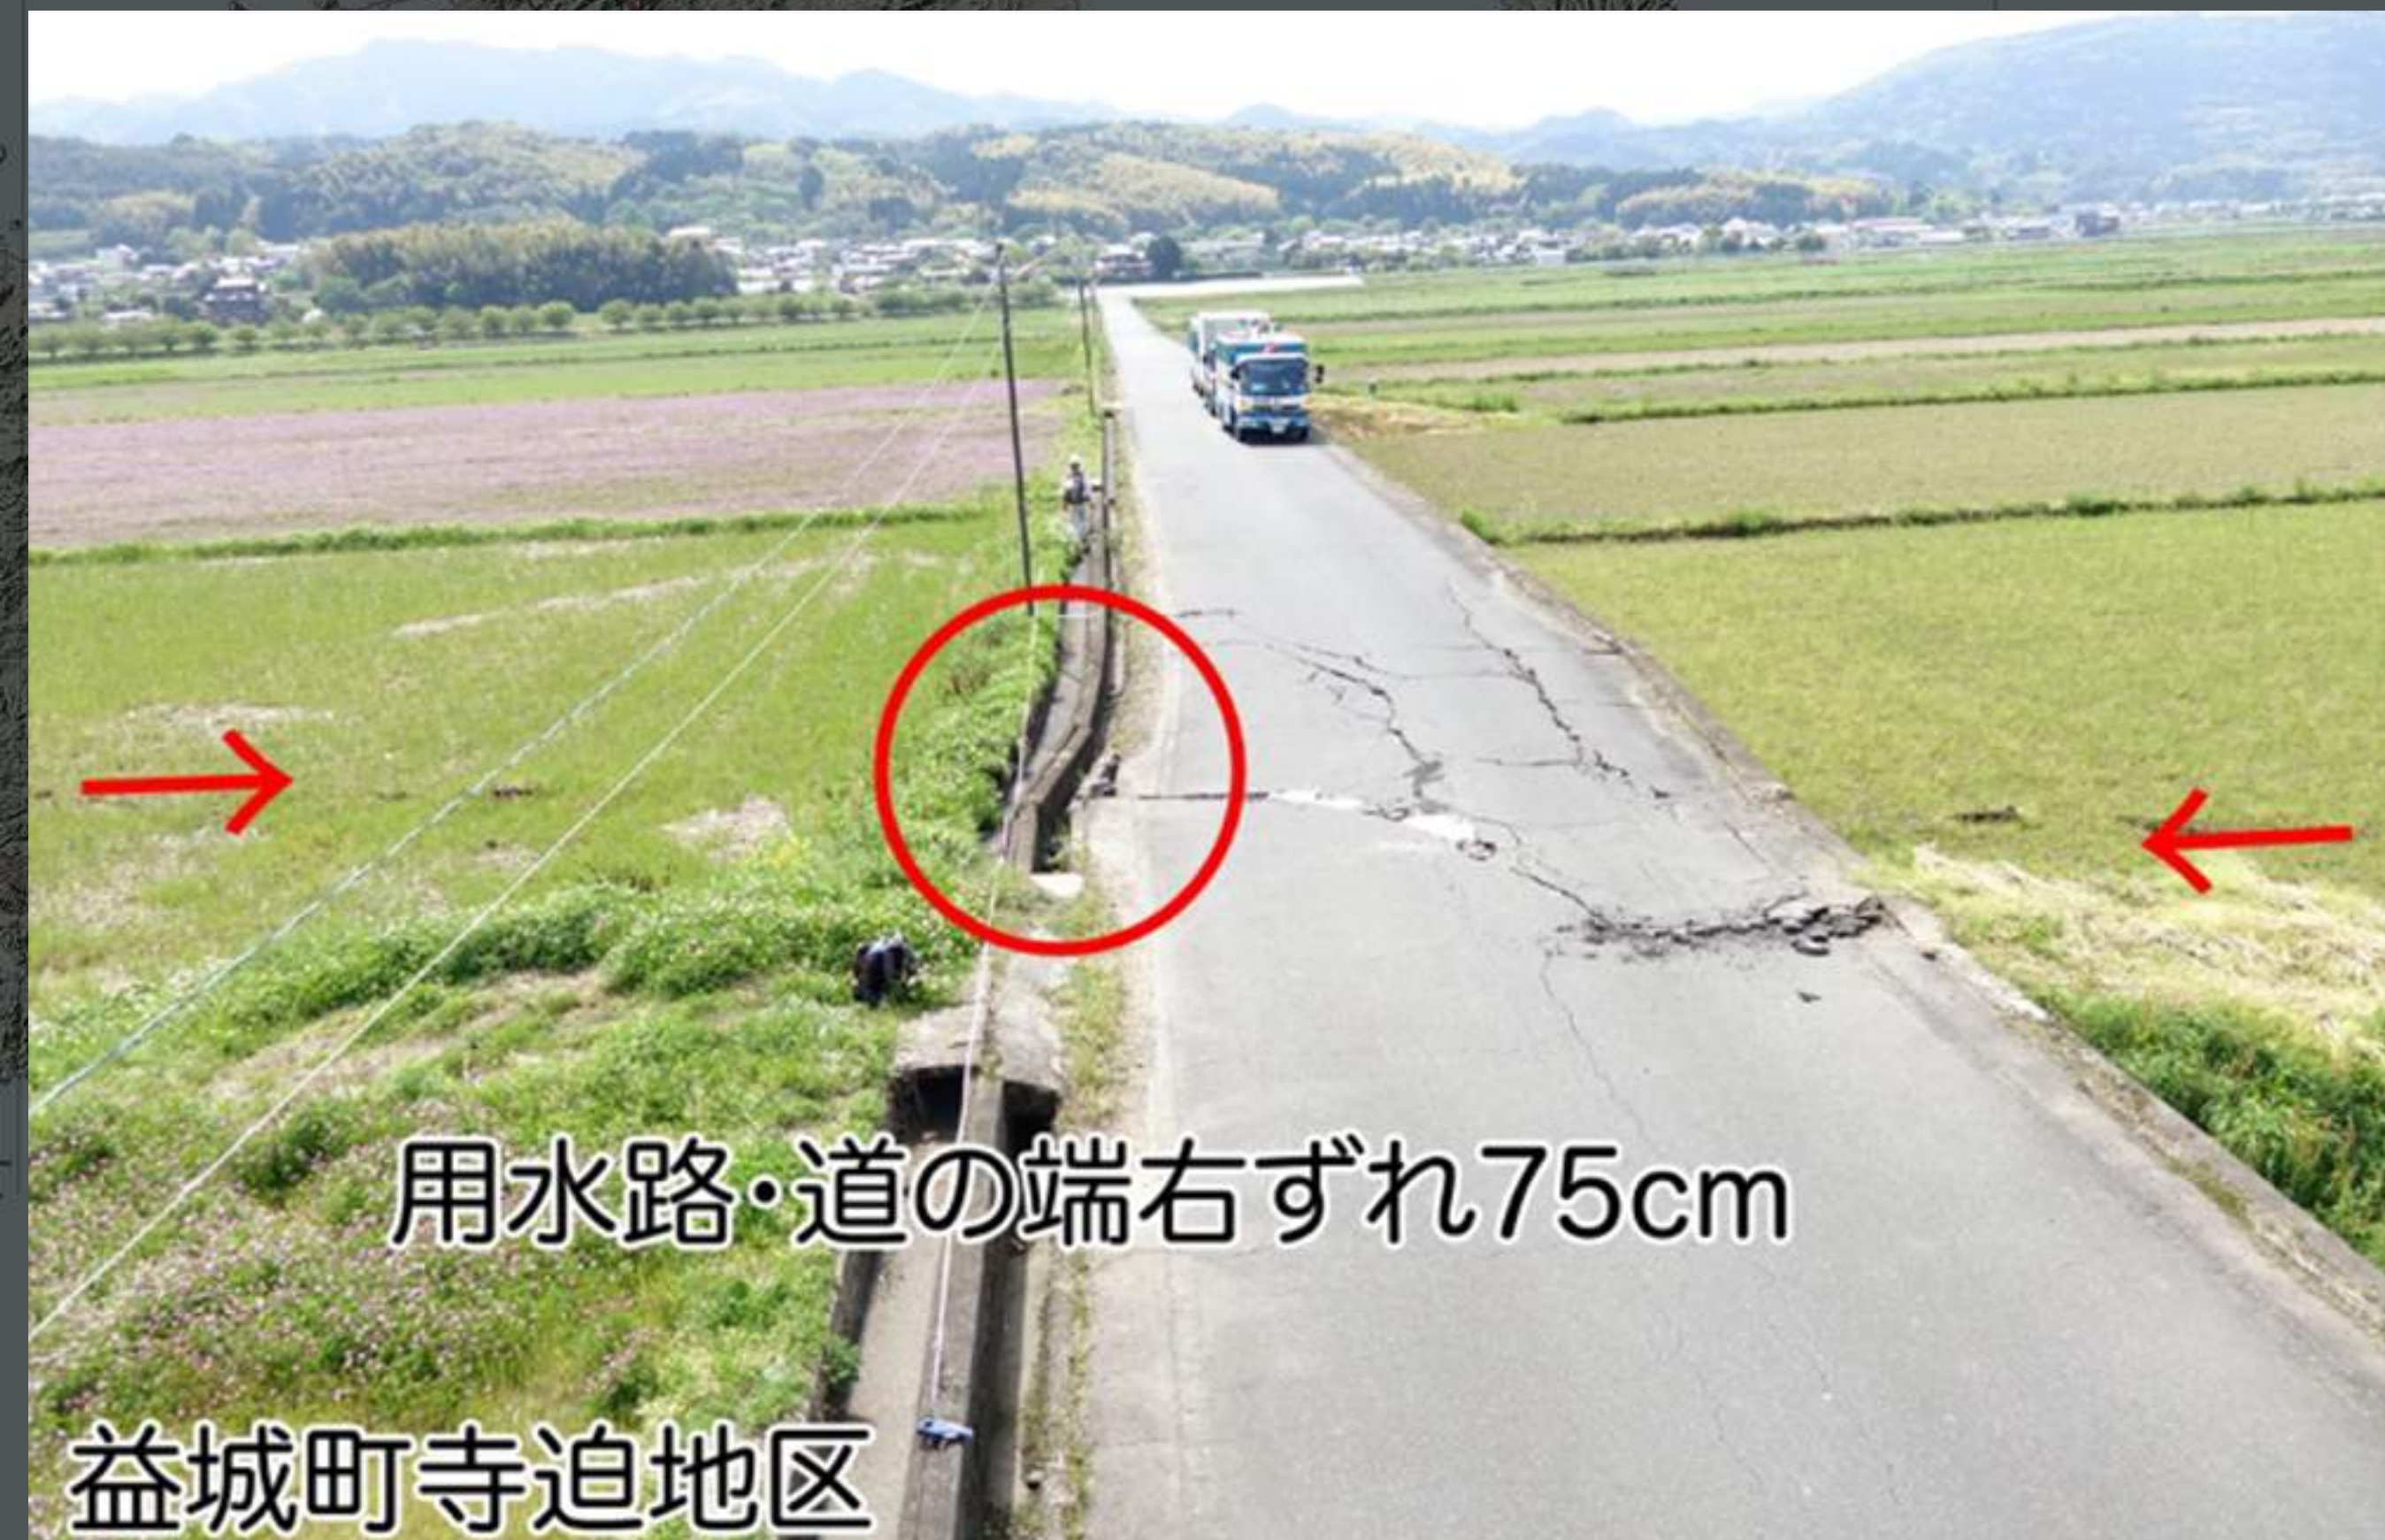
用水路・道の端右ずれ75cm

白線右ずれ40cm
