Kumamoto earthquake: a complex earthquake sequence with large strike-slip ruptures

Koji Okumura (Hiroshima University)
kojiok@hiroshima-u.ac.jp

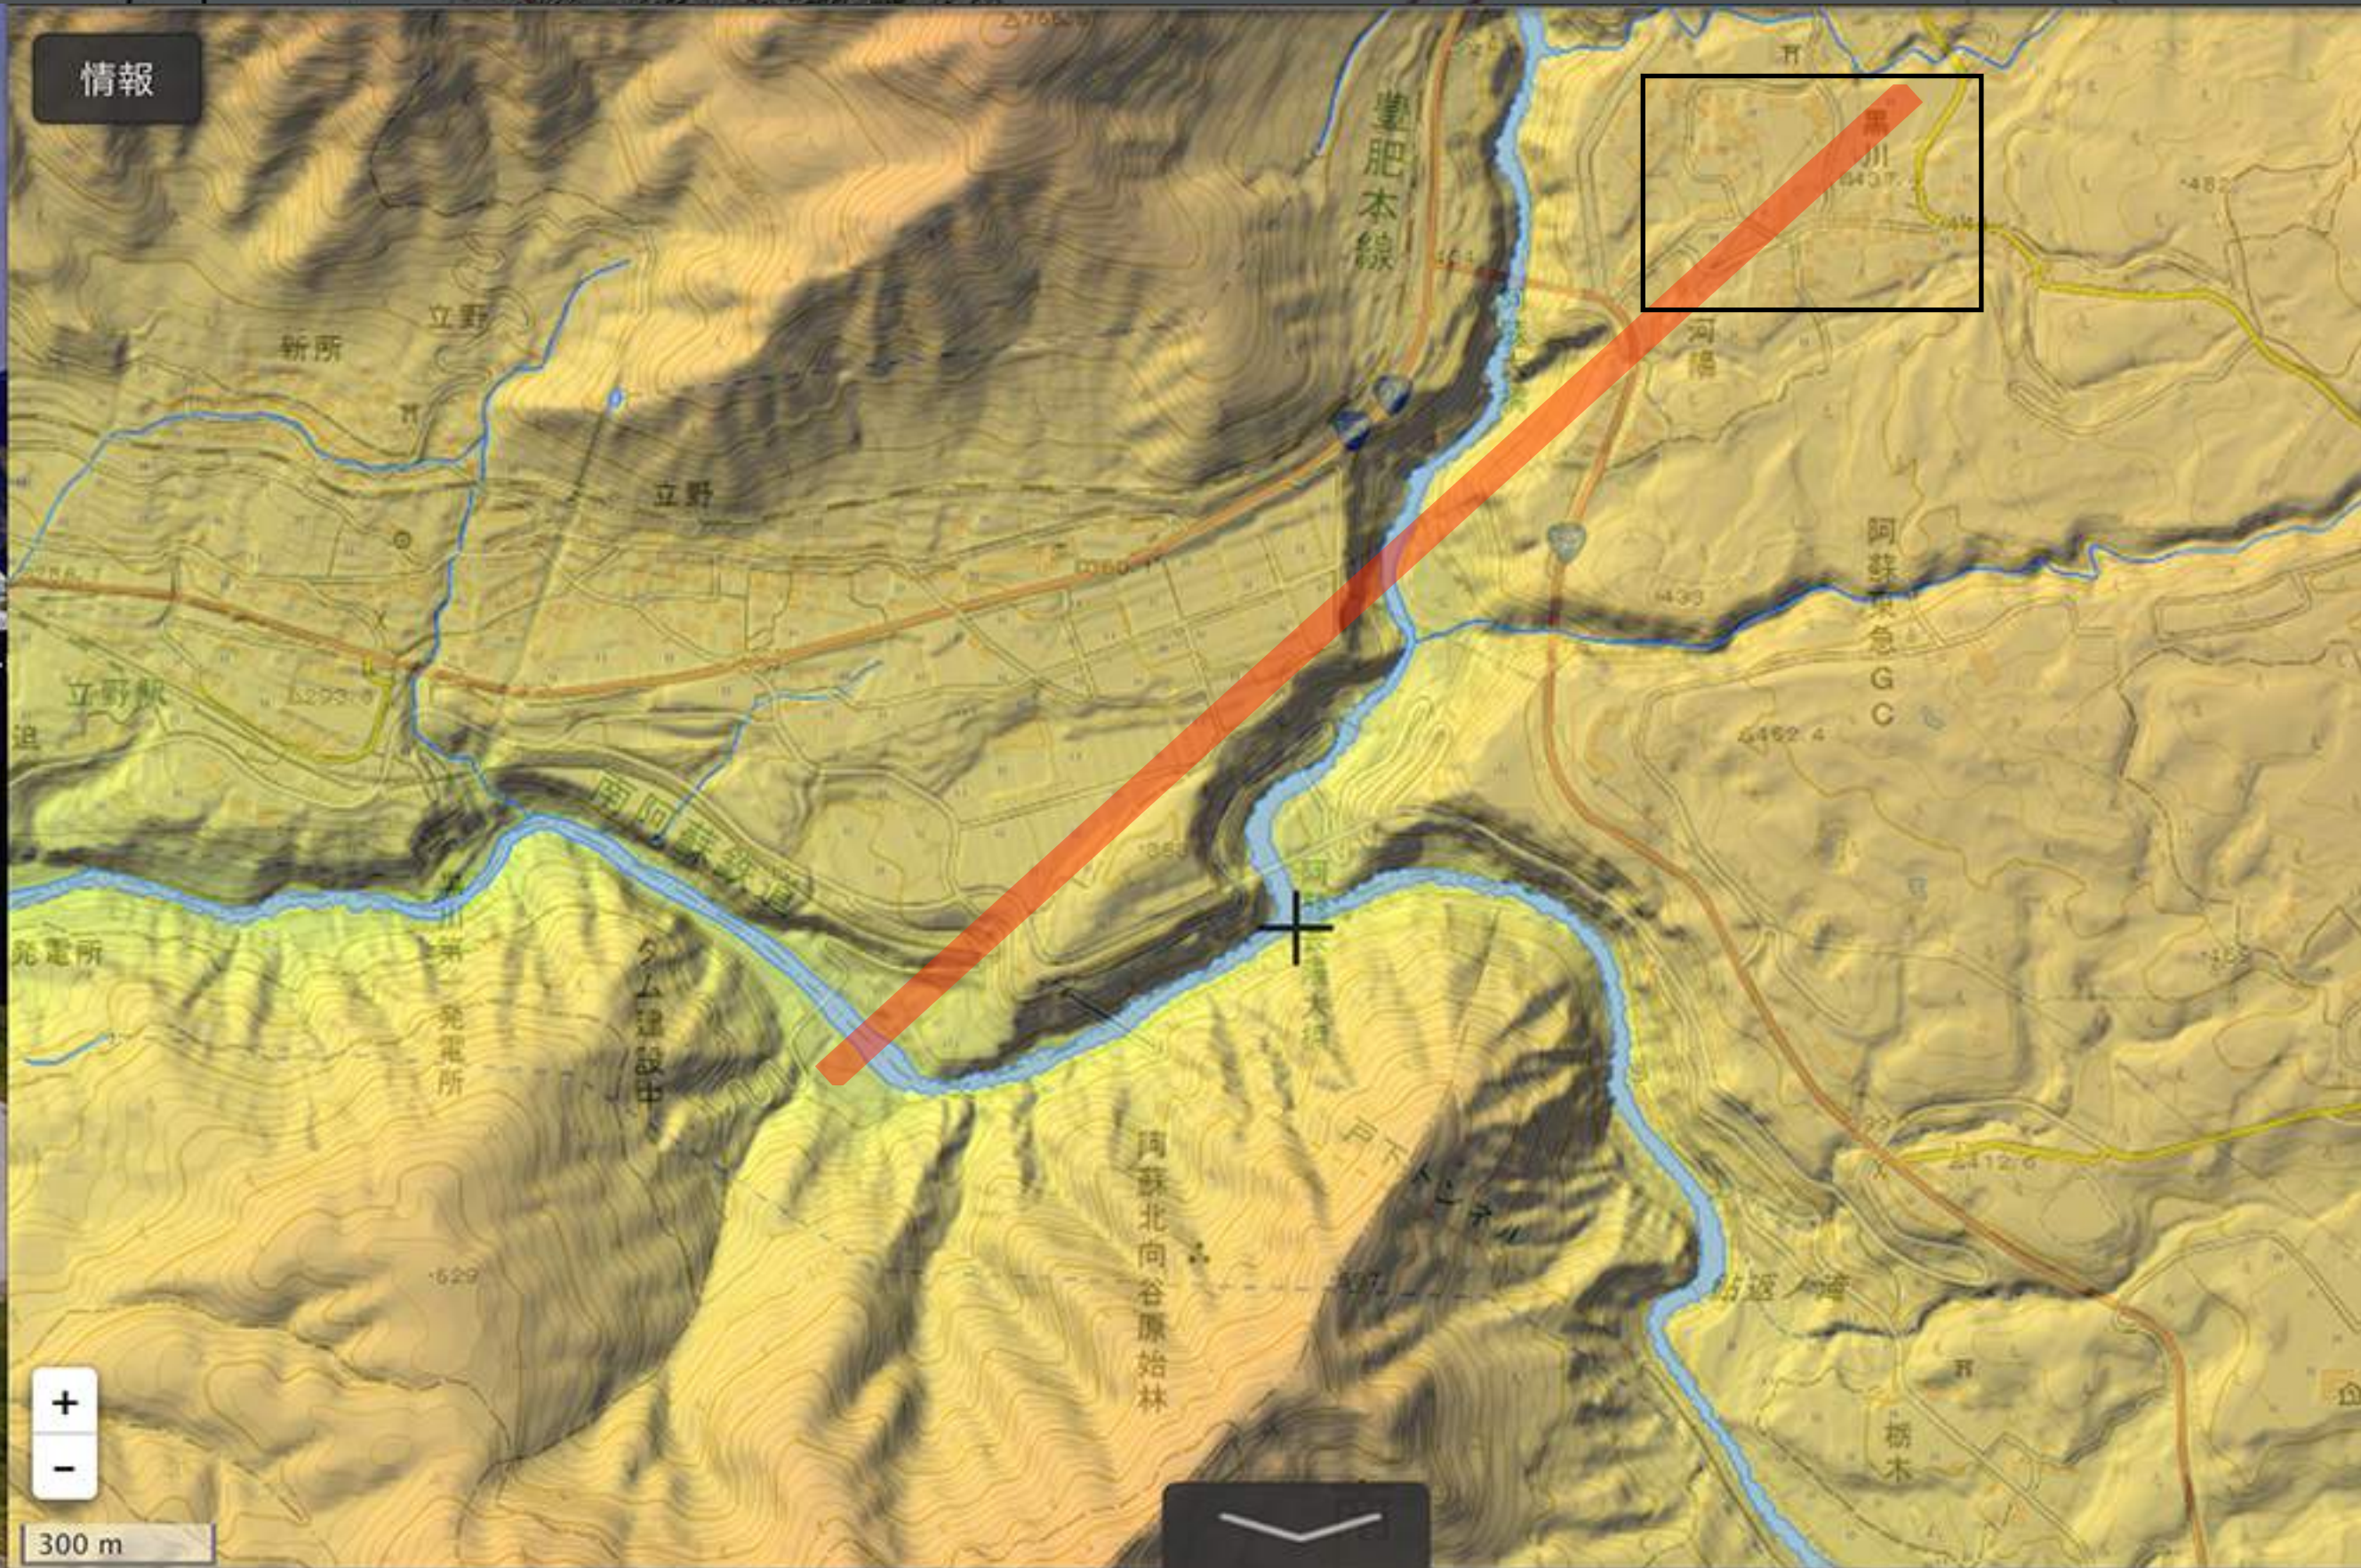
Previously unmapped fault across Aso caldera-rim.

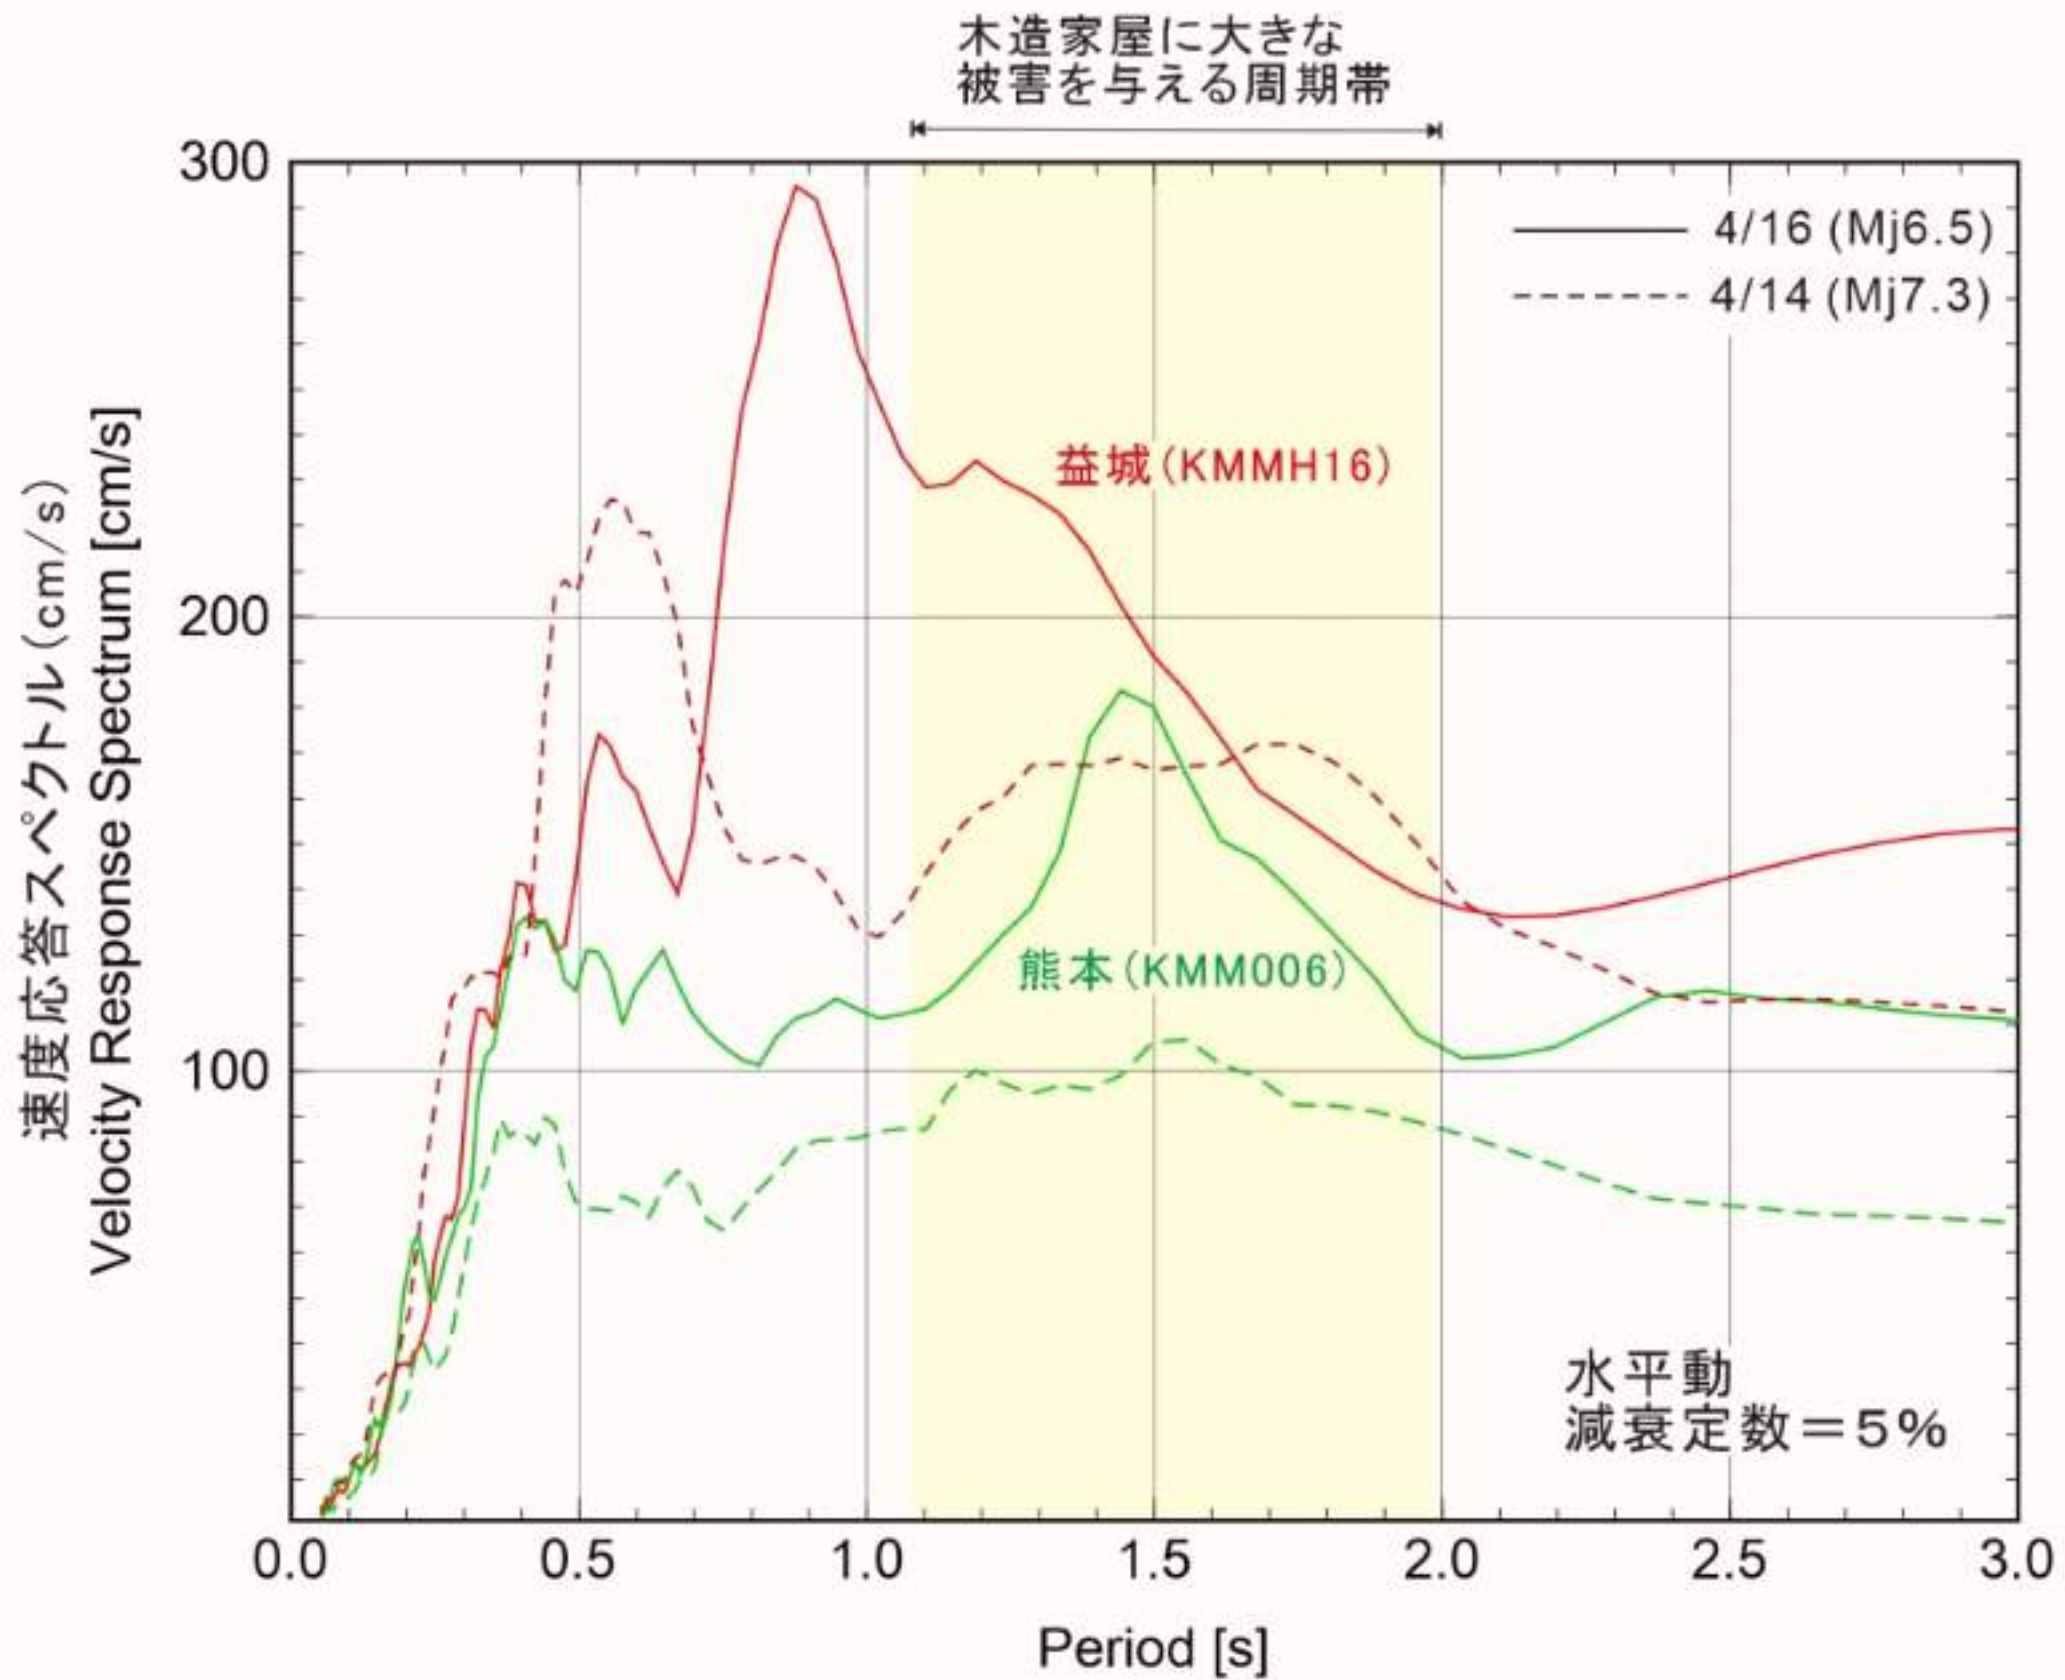
Velocity Response Spectrum by Furumura, ERI

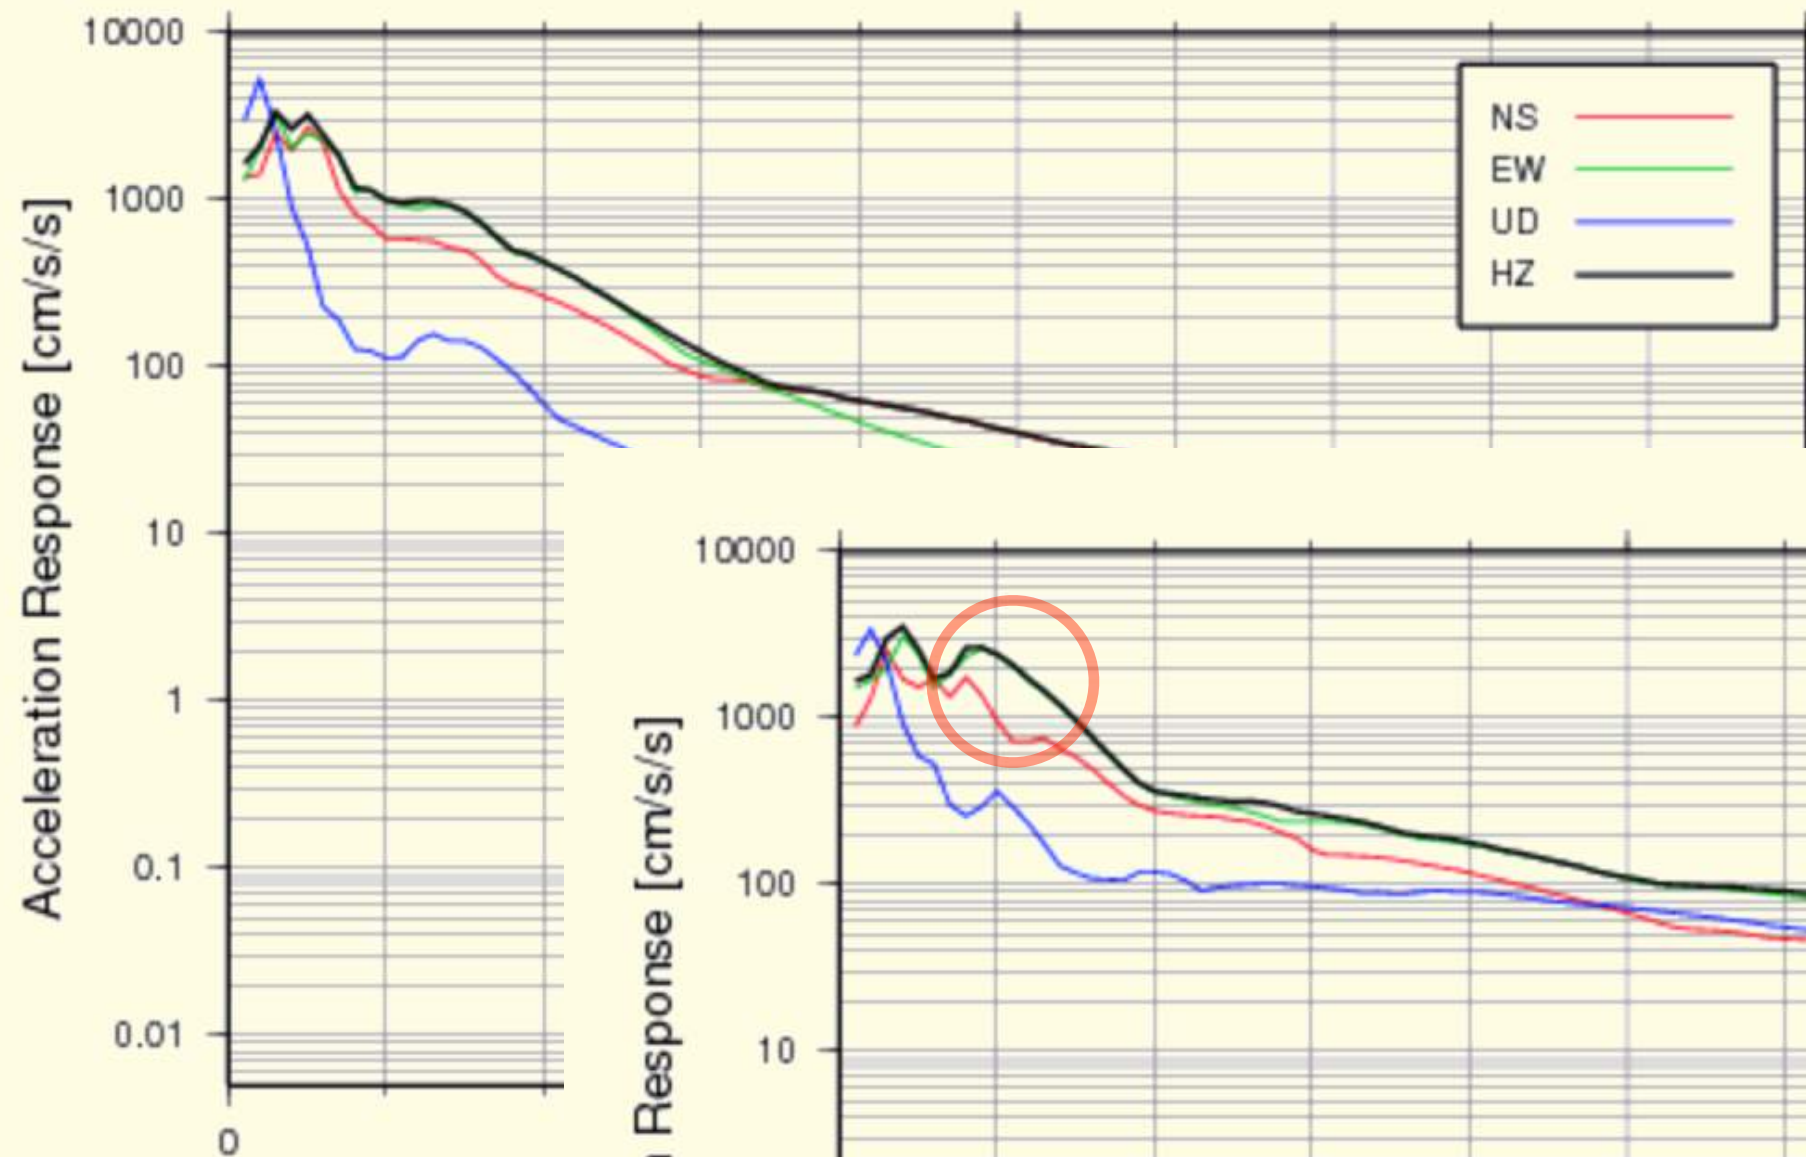
Mashiki
KMMH16
foreshock
Total 1.61g

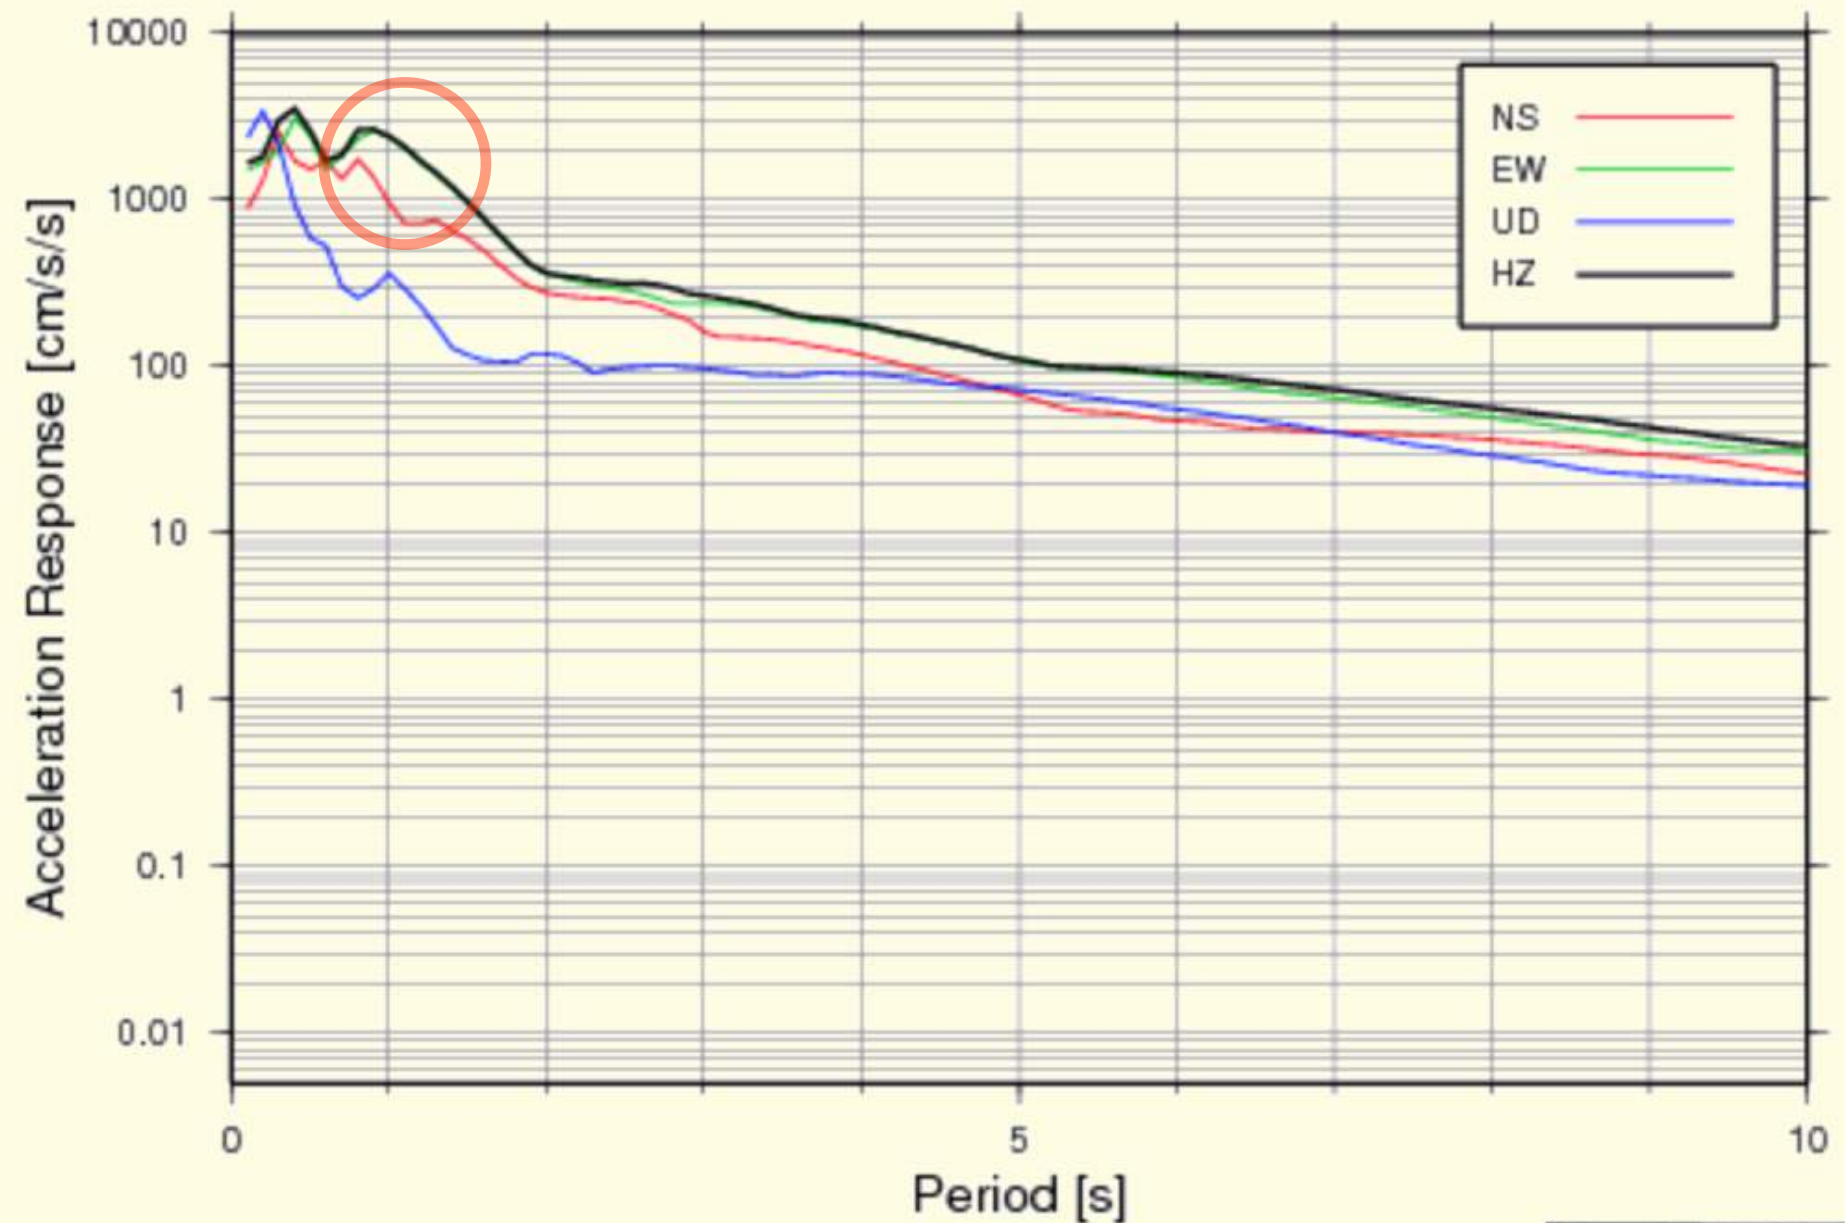
Mashiki
KMMH16
Mainshock
Total 1.35g

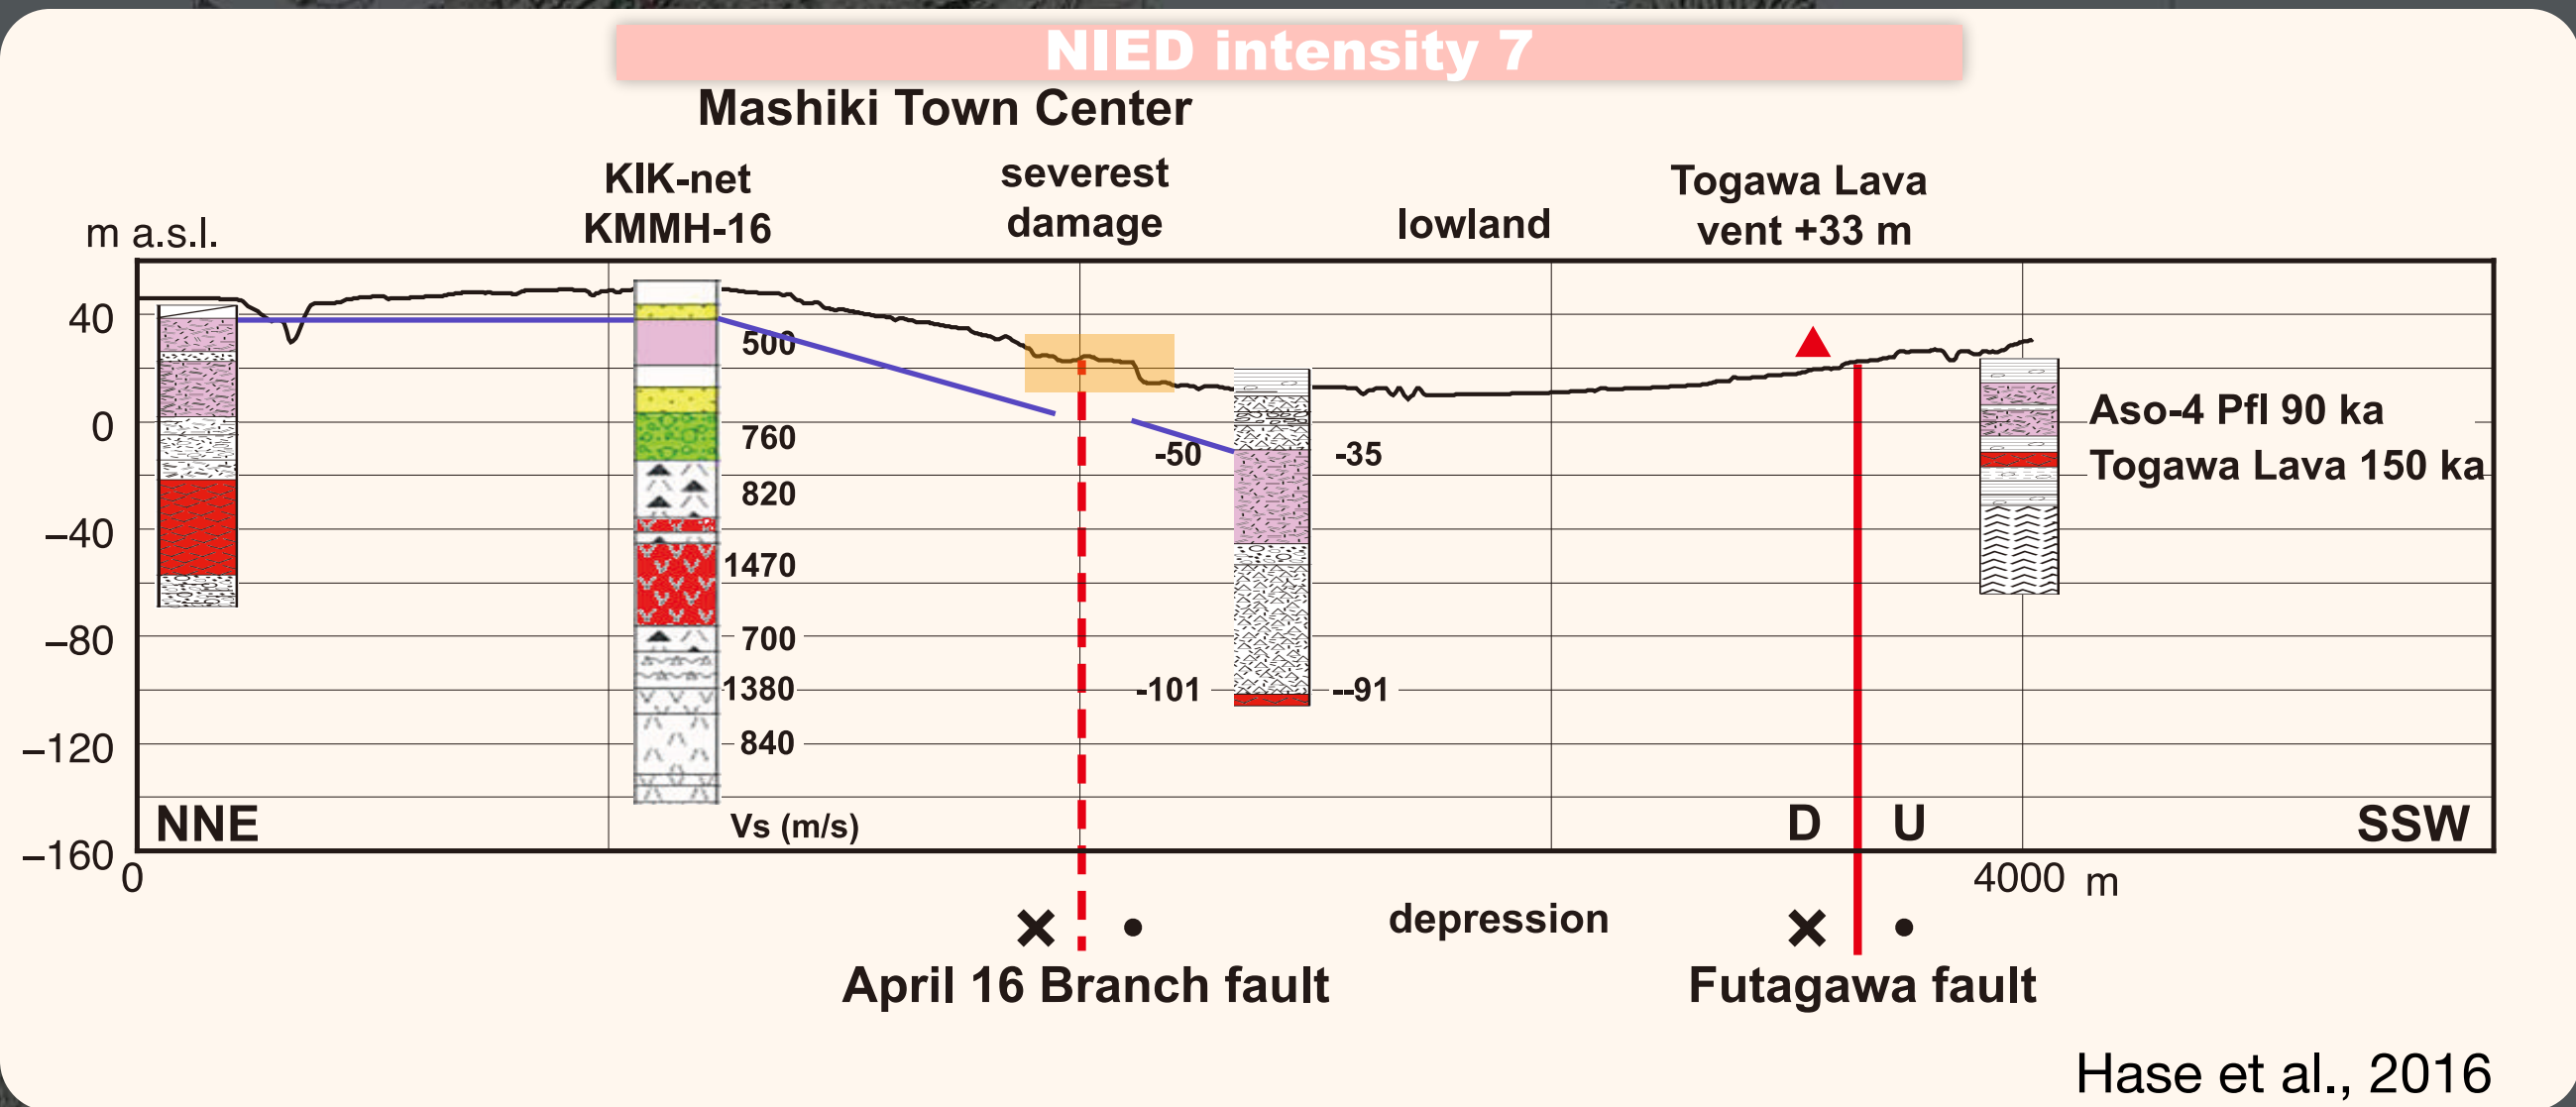
tilted surface
flexure?
blind normal fault?

50 m drop in 90 ka

Amplified ground motion by
-soft sediments in depression
-shallow anticline/syncline
-juxtaposition of soft and hard rocks
