Engineering and Geological Effects of the July 2019 Ridgecrest Earthquake Sequence

On behalf of the Geotechnical Extreme Events Reconnaissance (GEER) Association

Abstract

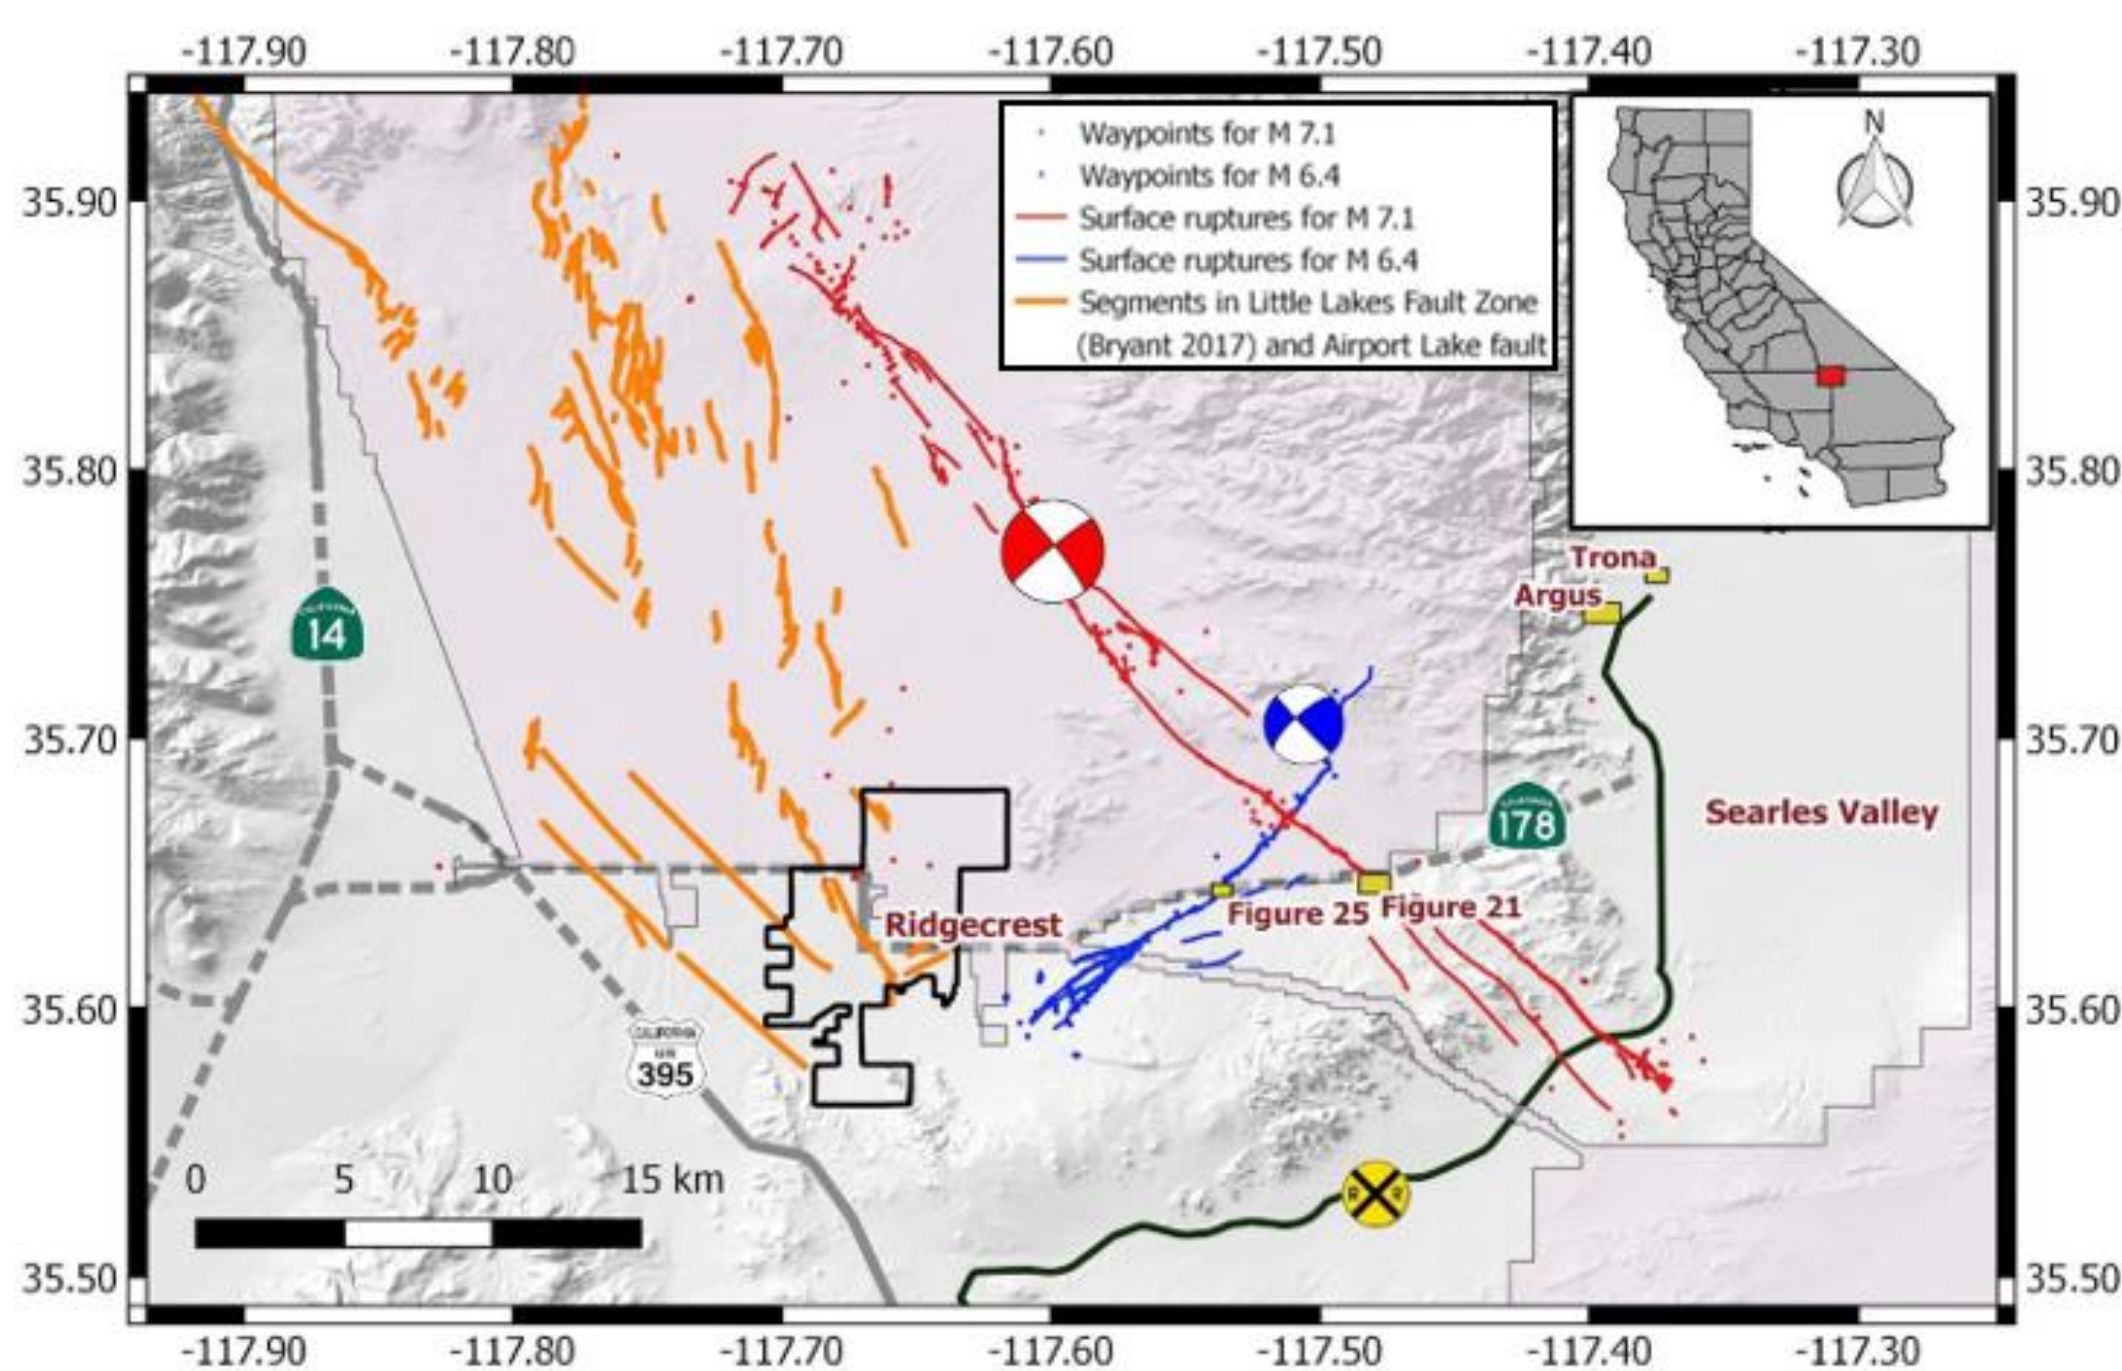
Figure 1. Provisional mapped surface ruptures and fault rupture observation waypoints of the M6.4 and M7.1 faults. Some of the waypoints may not be observations of fault rupture. The linear red and blue segments plotted on the map were constructed primarily based on ground observation locations, supplemented by interpretation of satellite interferometry correlation images from NASA's ARIA project to provide guidance for drawing the linework between widely spaced observations or where faulting is inferred from the interferometry but not field verified. Developed areas affected by earthquakes are indicated (Ridgecrest, China Lake Naval Air Weapons Station, Trona).

- M7.1 Event:** Surface rupture extent (red lines in Figure 1) mapped within NAWSCL, width varied from few meters in bedrock outcrops to over 300 m in thick soil deposits. Figure 5 shows fault crossing an access road within NAWSCL. Figure 6 shows ~4 m right-lateral offset. Features include left-stepping en-echelon fractures, fissures, and moletrack scarps.
